# International Journal of Advance Engineering and Research Development

## RESEARCH PAPER ON GEARBOX FAILURE ANALYSIS

**Abstract-** This paper presents an experimental investigation on gearbox failure of an automobile vehicle. Through the experiment it can identify the main causes of the issue and also the solution of the problem. There are various factors that affects and create a problem of gearbox failure. In this paper, discussion of some problems faced by the company along with their solution has been done.

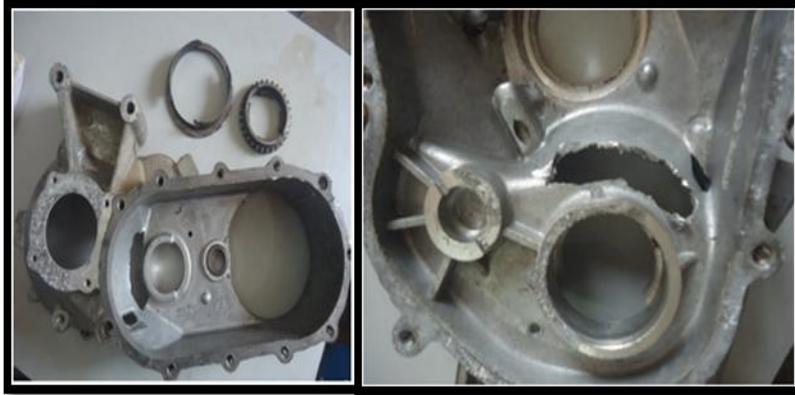
*Figure 1. Main housing broken*

From visible inspection we can see that Main housing is broken due to the some heavy particle collide to it, the metal parts of ball bearing and gears found in the housing, the metal particle should be responsible for the Main housing broken.

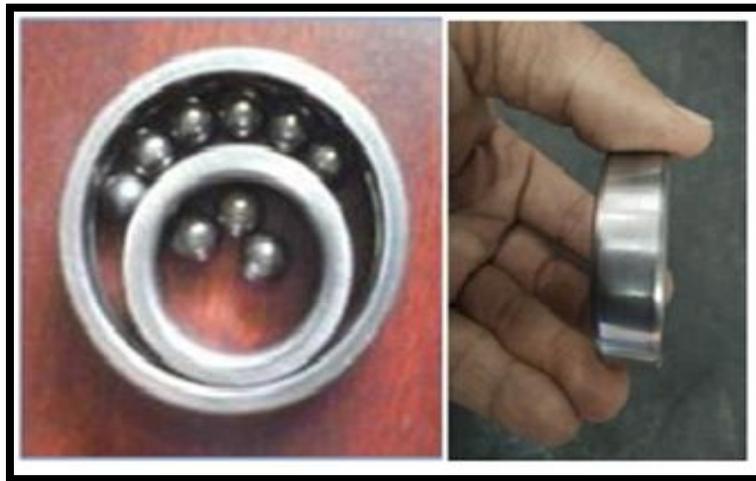
*Figure 2. Ball bearing broken*

Metal particles comes from the any part failure of gearbox, so the part failure of any component inside gearbox is responsible for gearbox failure. It may be from gear or ball bearing. Rubbing and shining mark found on the Ball bearing, we but it has to be verify with the vibration analysis. Flow chart for methodology is shown here.

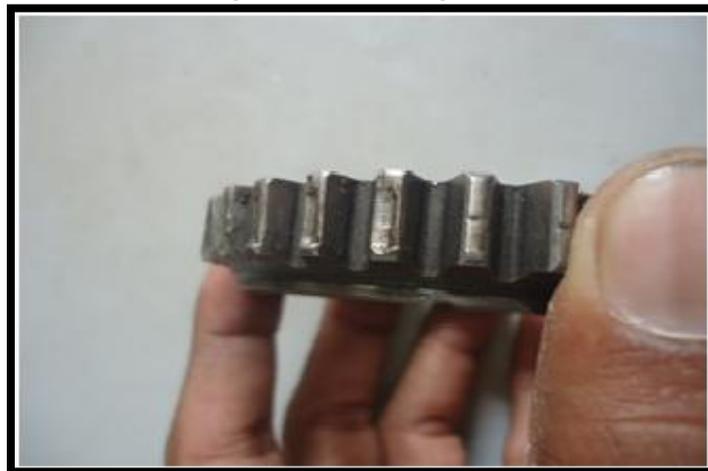
*Figure 3. Gear damage*

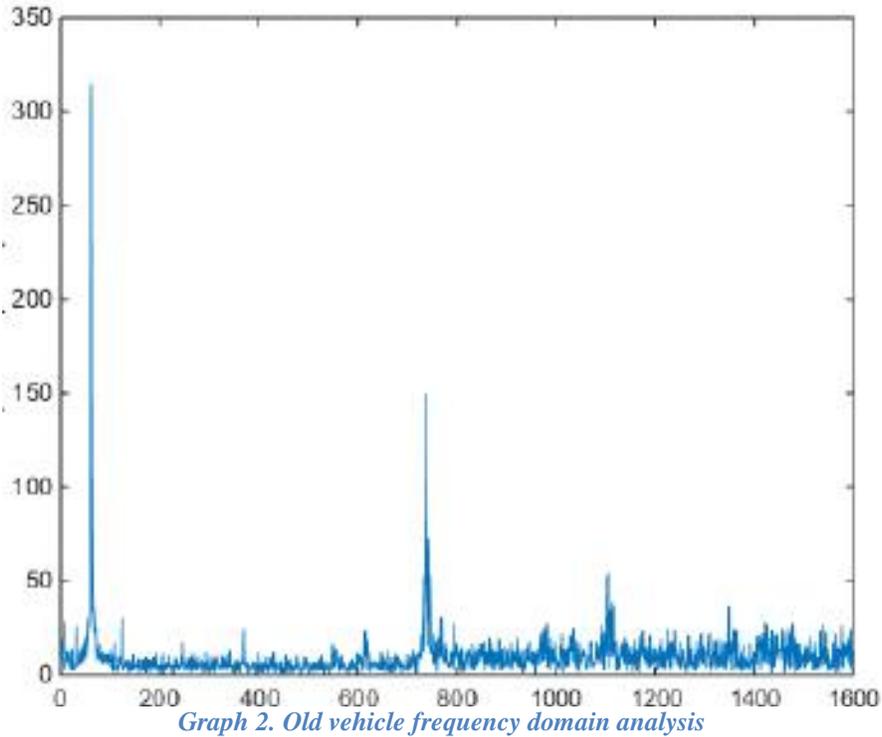
By comparing Graph 3 and Graph 4 we can see that there is abnormal rise in a Frequency at 750 Hz. For knowing the frequency of failure calculation has be done. As per 5 why analysis the bearing and tooth failure resemble major defect the calculation will be done for them first. If no frequency match then other failure frequency will be calculated [2]. For Ball bearing Failure frequency

As we can see that  $w_{bp}$  is 750 Hz, which shows that the outer race off ball bearing has some problem.

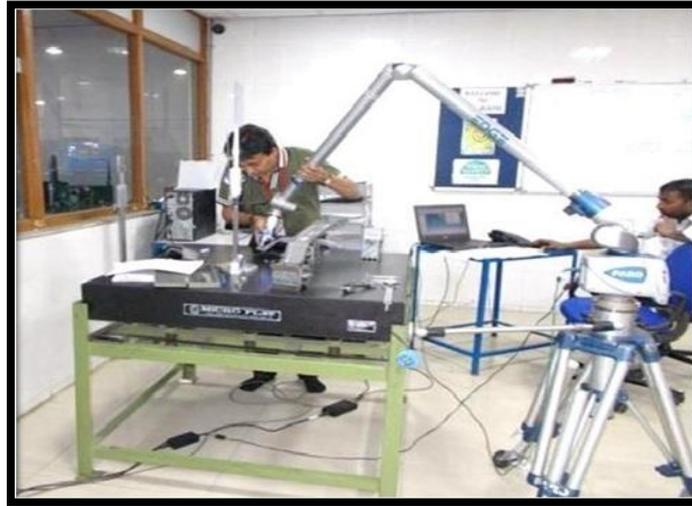
**Figure 7. Measurements on CMM**

In CMM it is found that the tolerance limits is between the  $+0.003$  to  $-0.022$ , which is not in the limits. Here more clearance is provided.

Bearing OD is higher than the OD of housing, bearing is press fitted here. Bearing clearance will decrease as temperature increases inside gearbox. But already more tolerance is provided which means that at higher the clearance will be more compare to desired value. So the bearing is loosely fitted inside housing, which will rotate at higher RPM, and also failure of other components. The new Tolerance Limit for Housing is  $+0.0030$  to  $-0.0010$ .
