Repair and Rehabilitation of Structure after Fire Damage: A Case Study of an Industrial Building

Abstract: This paper presents a case study on a rehabilitation of a fire damaged industrial building. Detailed site investigation and NDT test are conducted to decide the repair methodology. The fire incident took place in a mixer unit of a 50 year old manufacturing unit. The fire ignited at ground floor due to short circuit in electric panel. The mixer building is (RCC framed) ground and two upper floor structure. Concrete core samples are taken and tested for residual strength. Rehabilitation plan is designed on the basis of site investigation and results of test conducted.

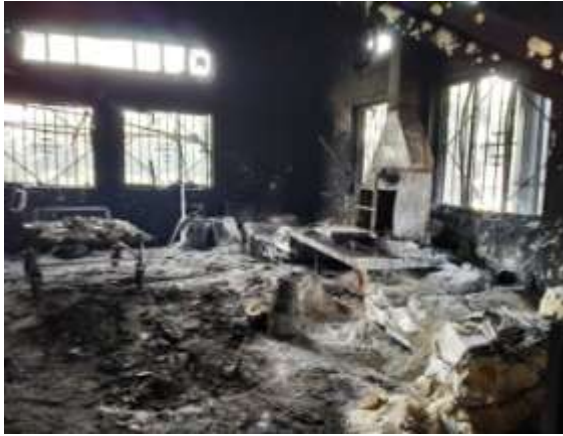
On the first floor reclaimed rubber, machine oil, FRP pallets and drums were kept. Rubber is burnt partially and pallets are partially melted. Remains of MS frame of oil drums neither bent nor melted. RC beam and slab in the grid B26-C27, D28-D29 were affected by fire and heat. Spalling of cover concrete is observed. Reinforcement is exposed in certain members. Inspection of mild steel reinforcement in RC members doesn't show any de bond condition. No powdered steel existence is observed. Freshly broken concrete shows grey colour. Plaster of all members is completely damaged on the first floor. Plaster surface shows crazing and cracking.

Fig.1 Interior view of the damaged building

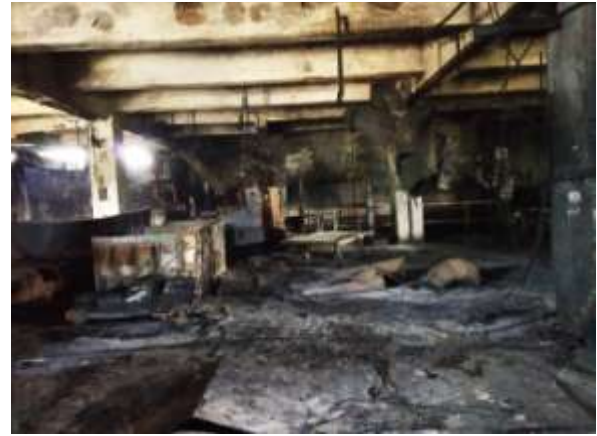
Fig.2 Interior view of the damaged building

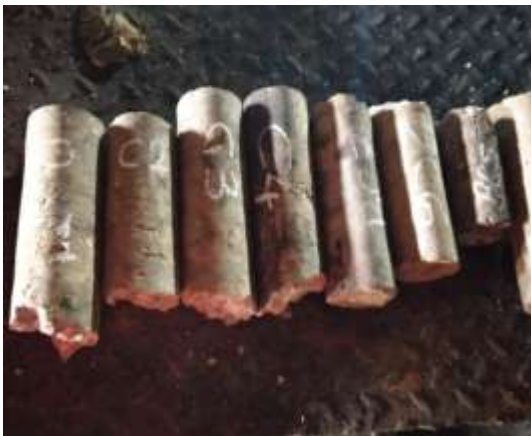
75 mm diameter cores taken from the different structural members like beam, column and slab. The 8 samples taken from the directly fire affected area of the building, while 6 samples taken from unaffected area of the building. Compressive test of this specimen is conducted as per IS 516. As per IS 456, clause 17.4, acceptance criteria, core test shall be considered acceptable, if the average equivalent cube strength of the cores is equal to at least 85% of the cube strength and no individual core has strength less than 75% of grade of concrete. The grade of concrete used is M15. The average core strength of unaffected area is 15.03MPa, while that of affected area is 14.75 MPa. The core sample test shows 2% drop in strength of concrete in affected area. Refer Table.1

Fig. 4 Core samples taken at site

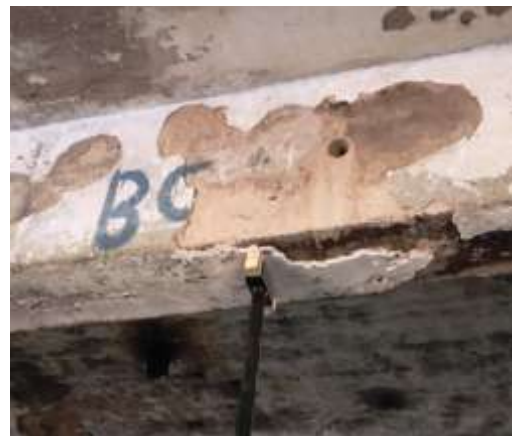
Fig. 5 Core sample from damaged beam

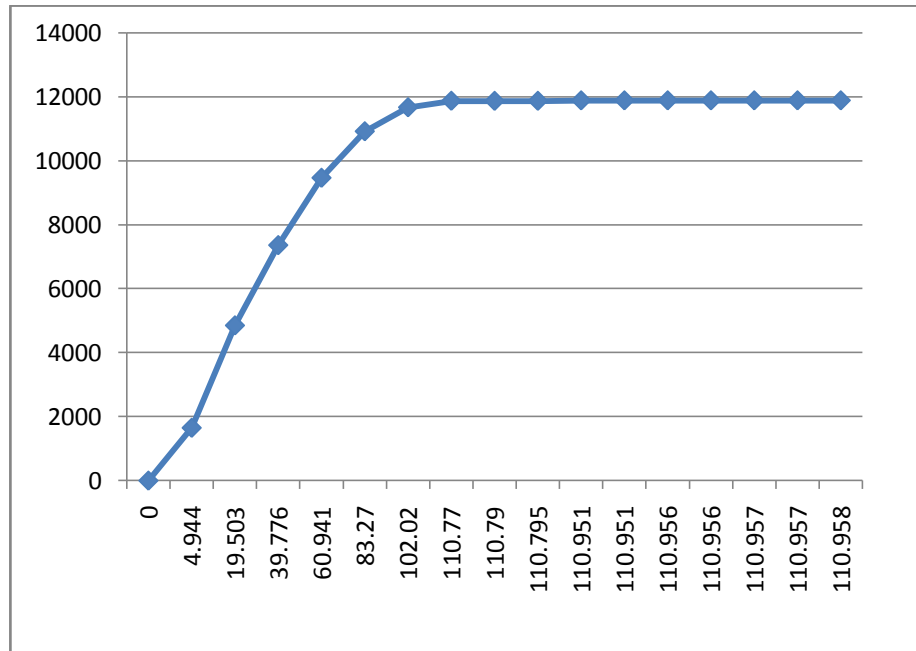
Fig 9 Force Displacement Graph in X direction

It is summarized from visual inspection and NDT testing those reinforced concrete elements inside the building are not majorly affected externally by the fire. Comparison of colour and texture shows that the elements experienced less than 600° C temperature. Push over analysis for earthquake stability of the structure shows immediate occupancy.

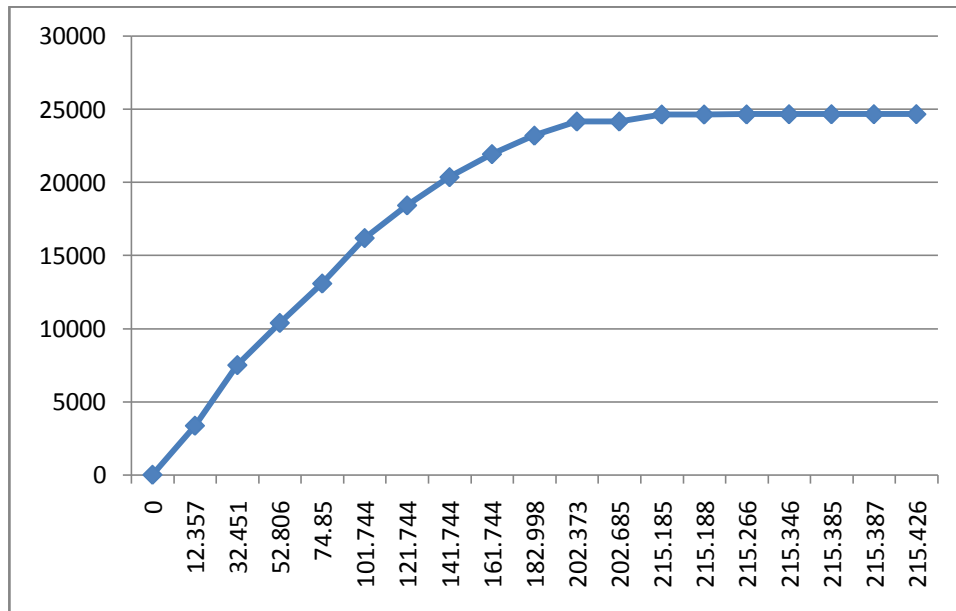
Fig 10 Force Displacement Graph in Y direction

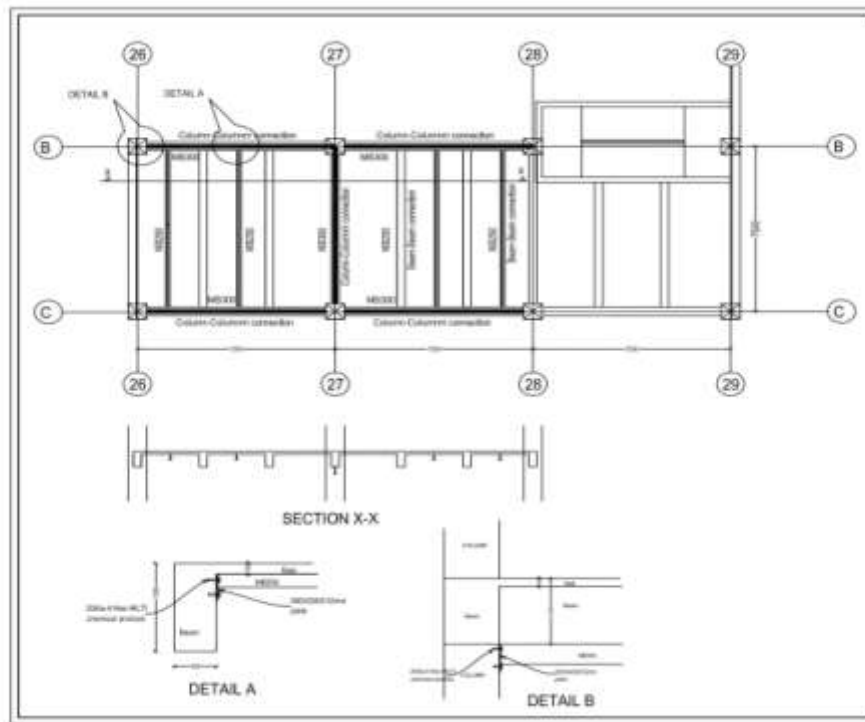
Fig. 11 Retrofitting plan

Based on the results of the visual inspection, NDT test, core test and push over analysis discussed in the previous sections, it is summarized that structural members are not affected much. Beam and slab are affected externally by fire. There is no appearance of server damage for RC members except spalling of cover concrete considering the serviceable life, as a precautionary measure it is necessary to strengthen some of the members, especially those are showing NDT results in poor class.

The slab needs to be repaired by surface repair method using epoxy-injection or mortar grouting. Beam and slab in grid lines B28- C26-C 28 are retrofitted by anchoring steel members to the damaged surface as below.

1. Beam and slabs at grid location B26-B28-C26-C28 needs to be strengthened as per drawing.
2. Slab surface at grid location D28-D29-E28-E29 and column E29 need to be repaired as per suggested repair methodology.
3. Lintel beams, External RC fins damaged during fire control needs to be repaired and restored.
4. Considering the life of structure and test results, it is recommended to limit the live load on the floor to 500 kg/m² though structure is designed for 750 kg/sq mt (as per reference of drawings).
