# Flexible Pavement Distresses- A Case Study

In the present paper, five road segments of SH-60 between Samarkha and Lingda in Anand district were selected. The length of each study segments is taken as 1 km. The main distresses observed were alligator cracks, longitudinal cracks, potholes, patching, ravelling, and rutting. The distresses observed are in terms of their extent or their measurements. The distresses that are observed in current study were due to the inability of the road to satisfy the demands of traffic and also due to environment.

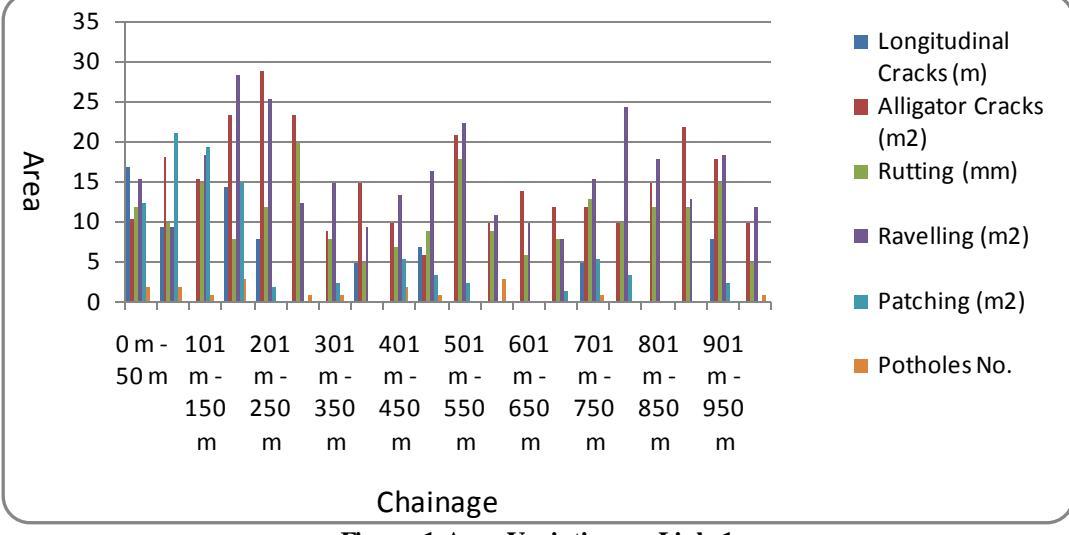
Figure-1 Area Variation on Link-1

- The different flexible pavement distresses observed on Link-1 and their extent are shown in Table-1 and visually it can be shown in Figure-1
- From the table below, it can be seen that alligator cracks and ravelling are predominant on the selected link.
- > Also the potholes are in large number.
- > In some sections of 50m, longitudinal cracks are also predominant.
- > In some sections of 50m, rutting and patching are also high.
- From table-1 and figure-1, it can be seen that distresses are more in the starting of the study link around 100m to 300m. where CBR is 10.25 and soil type is ML CL.

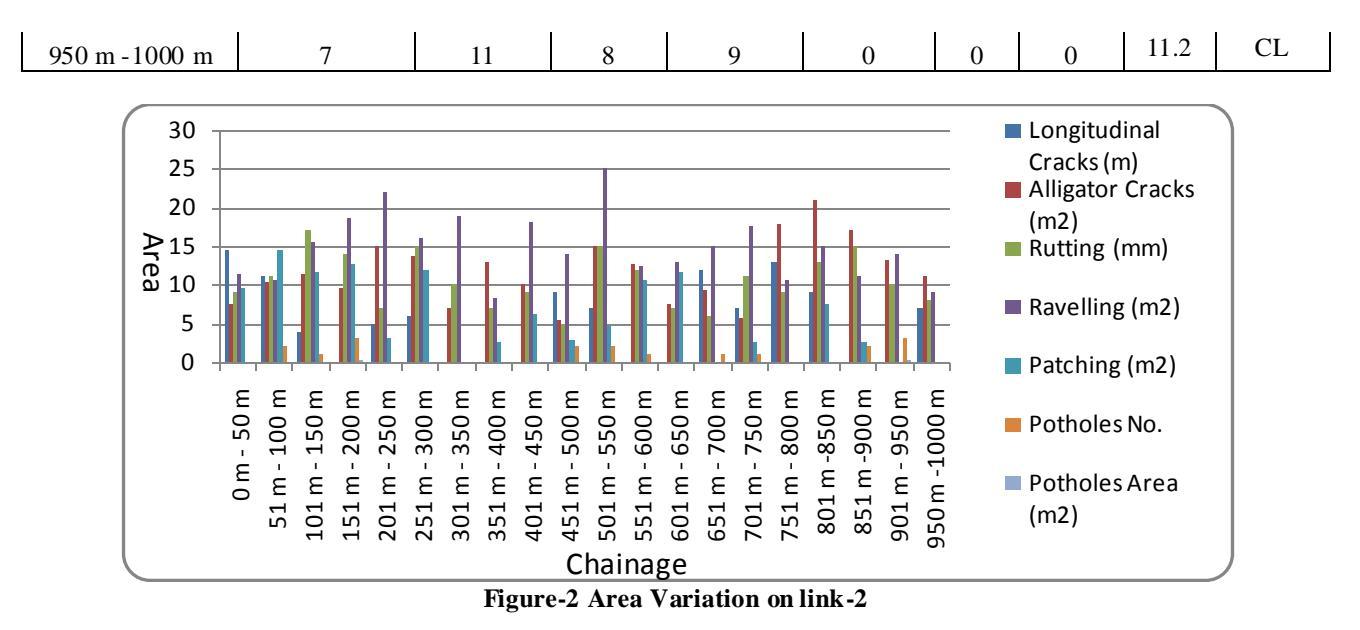
- The different flexible pavement distresses observed on Link-2 and their extent are shown in Table-2 and visually it can be shown in Figure-2.
- > From the table below, it can be seen that alligator cracks and ravelling are predominant on the selected link.
- > The potholes are in small number.
- > Patching is also more in some of the sections of the Link.
- > Rutting is also more in some sections of the Link.
- > We can also see longitudinal cracks on some sections of the Link.
- From table -2 and figure -2, we can see that distresses are more at the starting of the link from 0m to about 200m, where CBR is 12.10 and soil type is ML CL soil.

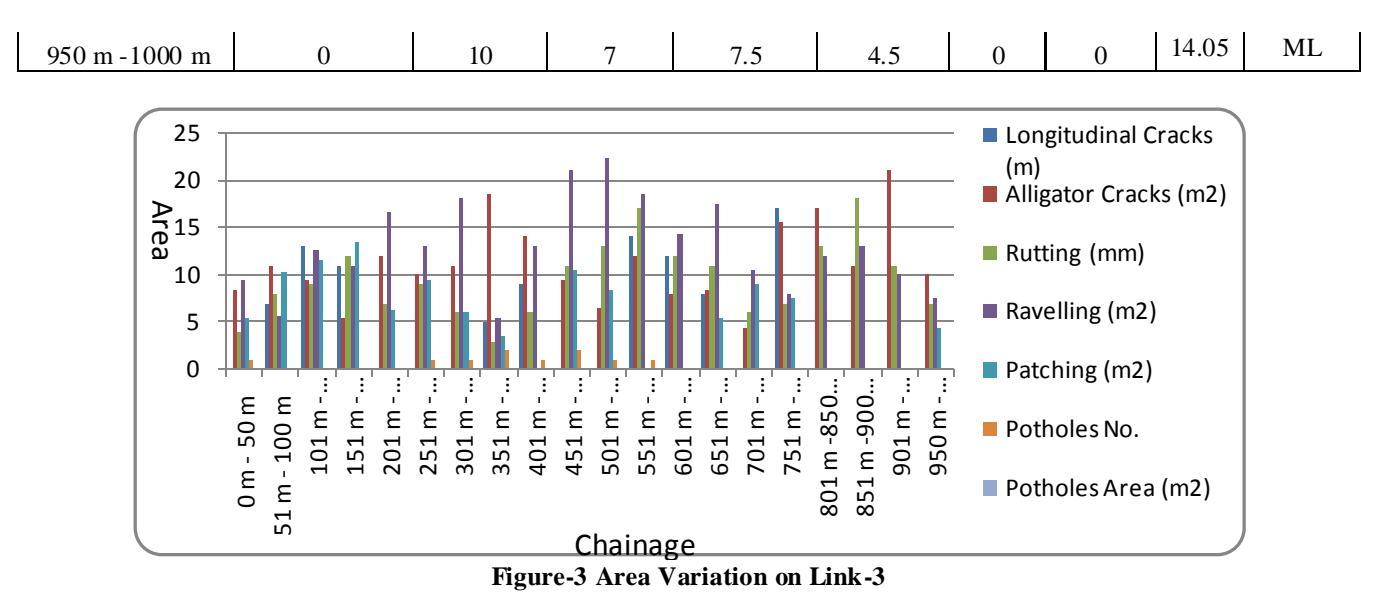
- The different flexible pavement distresses observed on Link-3 and their extent are shown in Table-3 and visually it can be shown in Figure-3.
- > From the table below, it can be seen that alligator cracks and ravelling are predominant on the selected link.
- > The potholes are in small number.
- > Patching is also more in some of the sections of the Link.
- Rutting is also more in some sections of the Link.
- > We can also see longitudinal cracks on some sections of the Link.
- ➢ From table-3 and figure-3, we can see that distress are more around 500m to 650m, where CBR value is about 12.45 and soil type is SM SC.

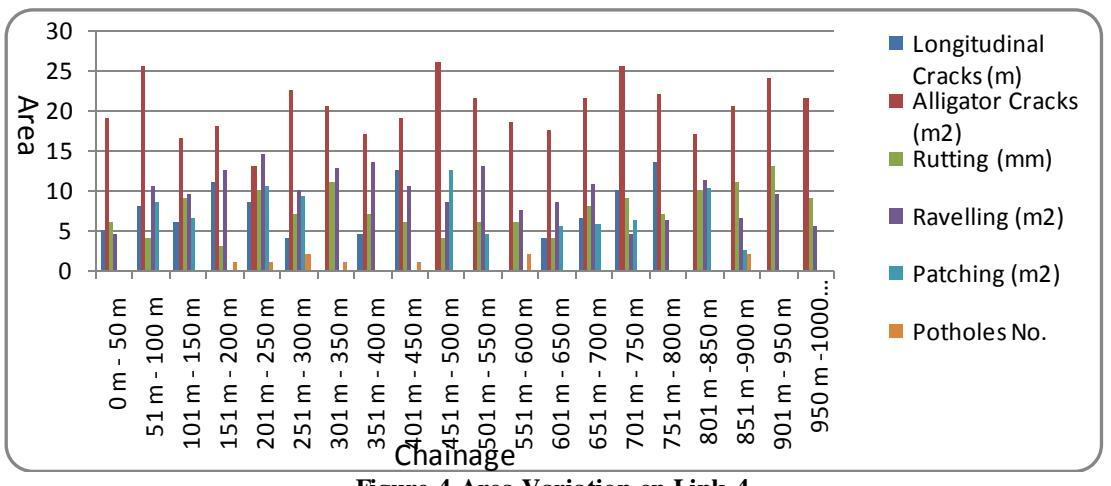
Figure-4 Area Variation on Link-4

- The different flexible pavement distresses observed on Link-4 and their extent are shown in Table-4 and visually it can be shown in Figure-4.
- > From the table below, it can be seen that alligator cracks are mostly predominant on the selected link.
- > There is considerable ravelling on the selected link.
- ▶ The potholes are in small number.
- > Patching is also less in the sections of the Link.
- > Rutting is in acceptable range in most of the sections of the Link.
- > Longitudinal cracks are present in some sections of the link and absent on the other sections of the link.
- From table-4 and figure-4, we can see that distresses are more at the starting of the link from about 50m to 300m, where CBR is 12.15 and soil type is ML soil.

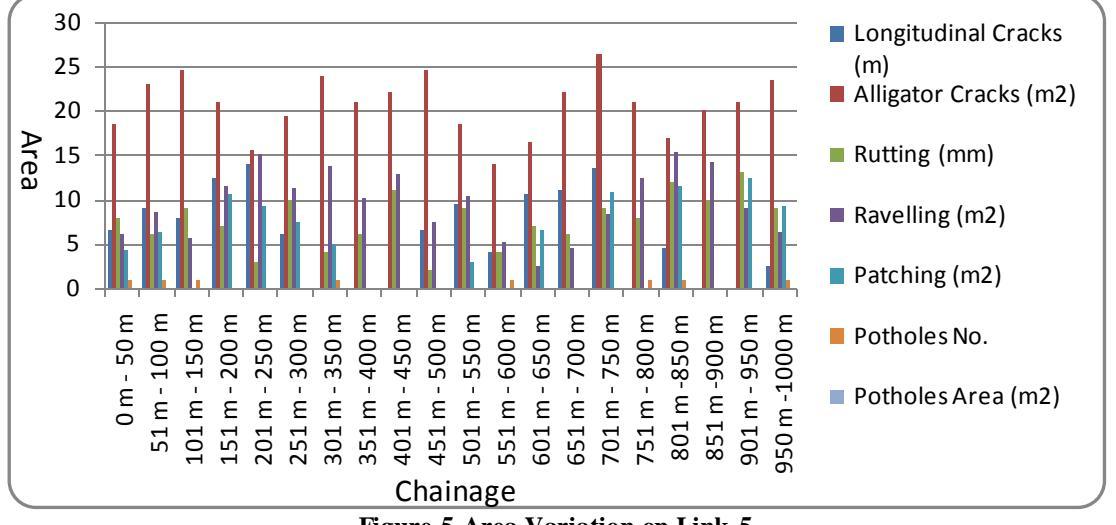
Figure-5 Area Variation on Link-5

- The different flexible pavement distresses observed on Link-5 and their extent are shown in Table-5 and visually it can be shown in Figure-5.
- From the table below, it can be seen that alligator cracks are predominant on the selected link.
- Ravelling is also more on the selected Link.
- > The potholes are very less in number.
- > In some sections, patching is present and in some section, patching is absent on the Link.
- > Rutting is in acceptable range in most of the sections of the Link.
- > Longitudinal cracks are present in some sections of the link and absent on the other sections of the link.
- ➢ From table-5 and figure-5, we can see that distresses are more between 150m-300m and 700m-900m, where CBR values are 11.26 and 13.41 respectively and soil types are SM SC and ML respectively.
