## RETROFITTING OF T-SHAPE BRIDGE GIRDER USING FRP

**Abstract** — The aim of this research was to check the possibility of using Fiber-Reinforced Polymer (FRP) material for retrofitting of T-shape reinforced concrete (RC) non-pre-stressed Bridge girders. From last few decades, the use of innovative composite materials such as Fiber Reinforced Polymer (FRP) for strengthening, upgrading and rehabilitation of existing reinforced concrete structures. It is use because of their superior qualities such as light weight, easy to apply, high strength to weight ratio, and show efficient performance in strengthening and up gradation of reinforced concrete structure. Non-pre-stressed reinforced concrete (RC) T-shape bridge girder model was casted which dimensions were  $\frac{1}{4}$  of the prototype bridge girder dimensions. After casting the girder they were tested and damage it to their ultimate strength. Girder model was failed only in flexural and flexural cracks developed only at four feet central span of the girders. Girder was retrofitted by externally applied of Fiber Reinforced Polymer (FRP) sheet with epoxy resin and also injected the epoxy resin into cracks. After retrofitting tes

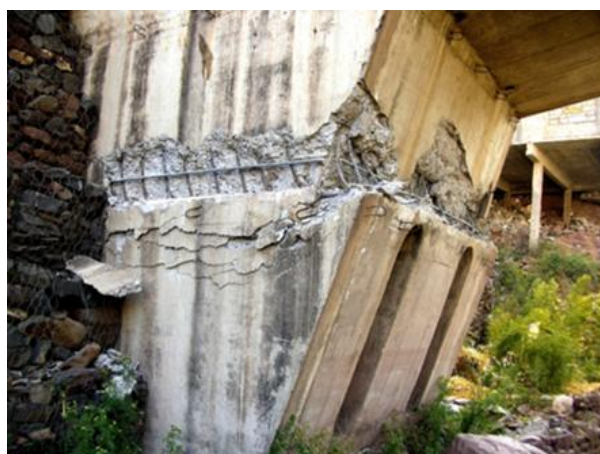
Figure 1. Shear failure of abutment at cold joint of Garhi Dupatta Bridge.

In October 8, 2005 Earthquake at least 20 major bridges were damaged and not in serves condition as shown in figure – 1 because the absence of bridge design code in Pakistan (Ali, S.M., et al. (2011)). Similarly in 2010 Pakistan floods at least 150 bridges were damaged only in KPK Pakistan. Different materials and techniques are used for retrofitting and rehabilitation the reinforced concrete (RC) structures. The retrofitting and rehabilitation techniques includes fiber reinforced polymer, Grout injection, Shortcrete overlay, Repointing, stitching of cracks, and Ferro cement overlay etc. From last few decades, the use of innovative composite materials such as Fibre Reinforced Polymer (FRP) for strengthening, upgrading and rehabilitation of existing reinforced concrete structures composite (ACI 2007, Hollaway and Teng 2008). It also use to upgrade the deficient, deteriorate and damage reinforced concrete members by seismic activity or any other source because of their superior properties such as light weight, flexibility, easy to apply, resistance to corrosion, high strength to weight ratio, easy to transport, high alkali and fatigue resistance.

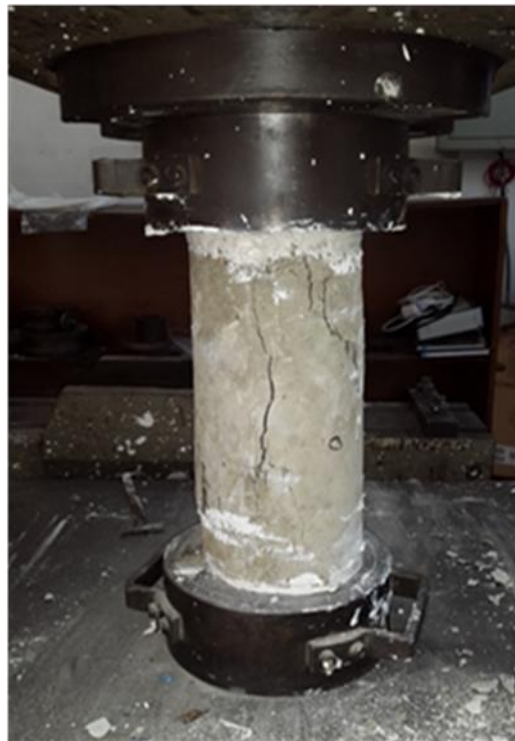
**Figure 3. Testing concrete specimens in lab**

To achieve the required strength of the concrete for girder model by performed the mix design and set the ratio for concrete mix as shown in table 2. Made the concrete cylinder and cured as per ASTM C192. After curing tested the specimens in laboratory as per ASTM C39 as shown in figure 2 which were approximately equal the strength of the concrete used in prototype bridge girder. Three steel bar of each diameter were tested under tensile load as per ASTM A615 to set the strength of the steel bars according to the steel bars used in prototype bridge girder.

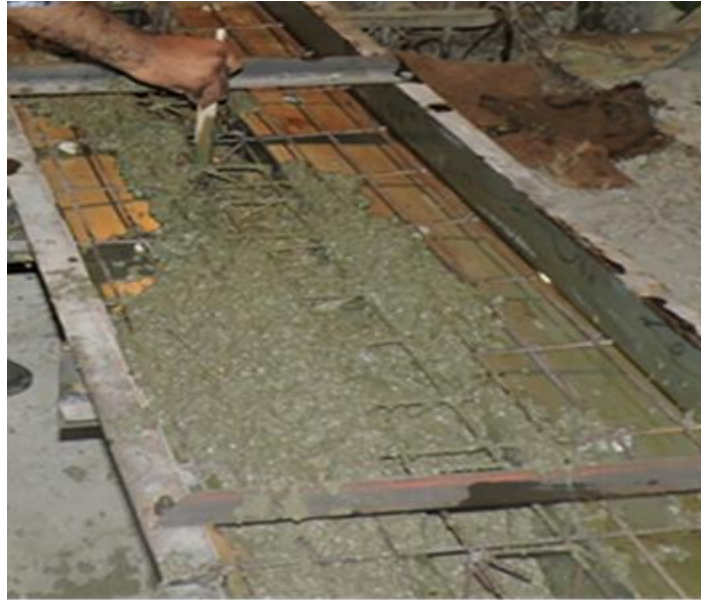
**Figure 4. Pouring of concrete in girder form work**

T-shape RC girder model was cast by using steel form work for good quality of work as shown in figure 3. After casting placed the girder for curing for 28 days that they achieved maximum strength, the girder was tested under monotonically increasing four points loading as shown in figure 4. The Girder was damaged only in flexural under the loading demand as shown in figure 5. Only flexural cracks developed at mid span of the girders. Girder were retrofitted only in flexural by externally applied the Carbon fiber Reinforced Polymer (CFRP) sheet with epoxy resin.

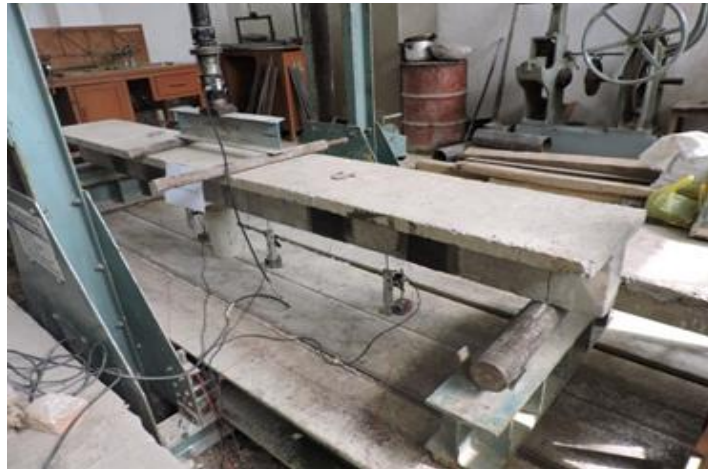
**Figure 5. Test setup for T-shape girder model**

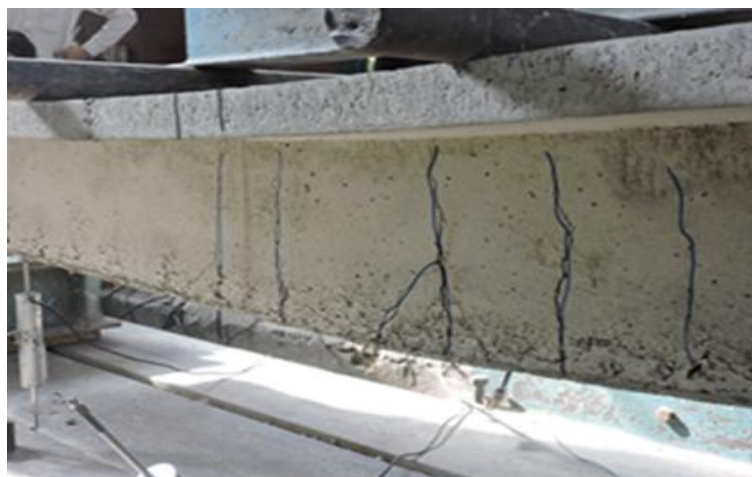
**Figure 6. Failure of girder before Retrofitting**
