**ANTI- THERMAL STRUCTURE**

JAY DALAL

MIT – ADT UNIVERSITY, PUNE, INDIA

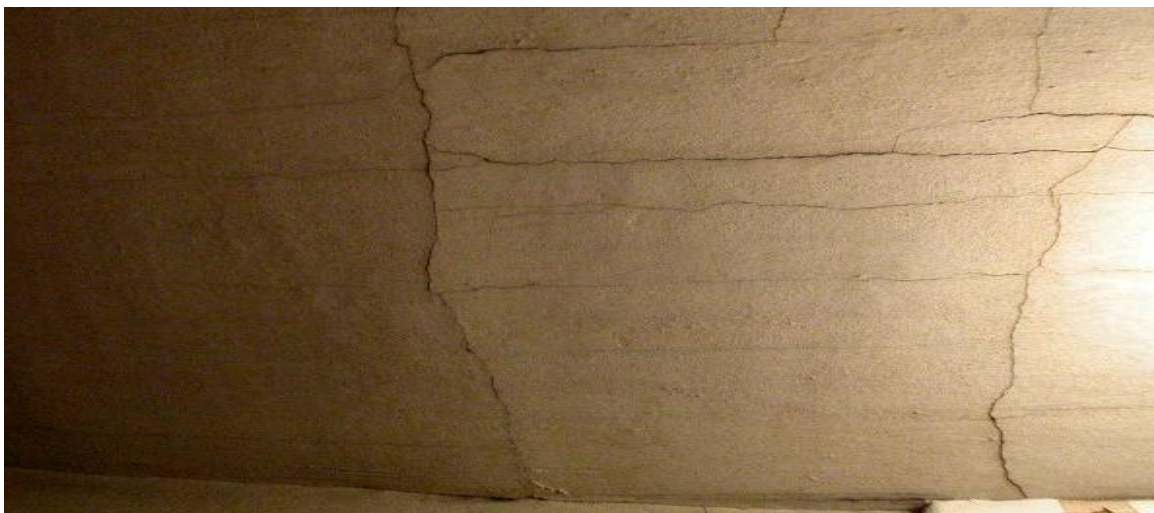
HEAT OF FURNACE/ BOILER/ OVEN:

Recently we had visited Excel Crop care Ltd. The building was constructed in 2000. At Gajod - Kera. We founded the problem in the industry was Failure of wall due to heat of furnace. We saw that the Plaster of wall was falling due to heat of Furnace.

This Picture was taken at Excel Crop Care Ltd. on MARCH 10 at 3:00 pm. The Structure was Post-Earthquake (Approx. 10 years). There we saw that cracks was developed in the wall and plaster was falling from the wall due to heat of Furnace.

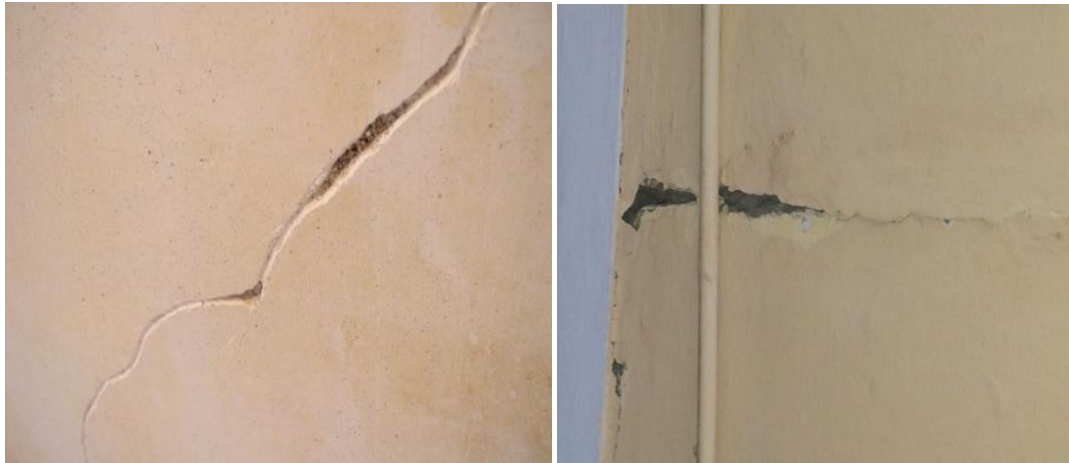
#### **CRACKS IN THE WALL:**

In this picture that cracks are developed in the wall. The more cracks takes place at corners, but here in this case cracks are developed at not only corners but in the center of the wall. Normally the cracks in the wall takes place by naturally or natural calamities like Earthquake. It is also the cause of external heat from the atmosphere which has impacted the wall very badly and as a cause it leads to cracks.

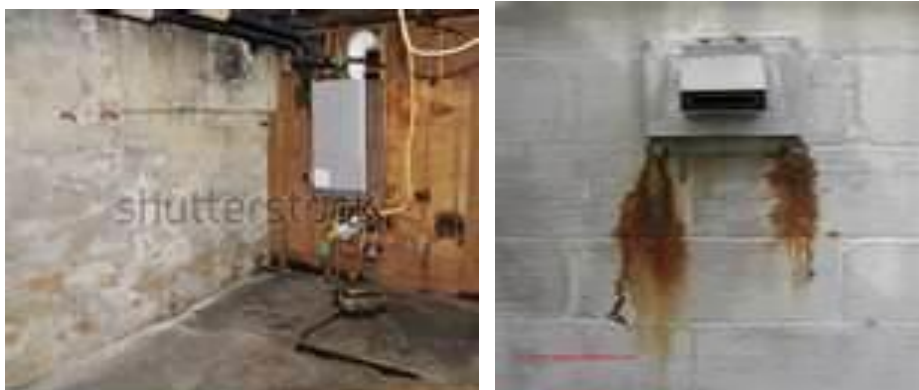
#### **HEAT OF FURNACE ON THE WALL:**

The pictures shows that how the wall is affected by the heat of furnace. The wall badly affected by the heat. Even in case of oven the same effect takes place, here furnace is connected to the wall and the wall gets reacted by the effect of heat.

This is just because of heat on the wall surface as it has damaged the wall very severely and as a result it also affects the internal electrification and the wiring which has been done just after the construction of the wall. Here, instead of using conventional materials special insulating materials should be used to prevent the deterioration of the wall and left such thing in adverse condition.

Heat Insulating materials such as thermal resistant bricks and cement should be used to prevent such type of damage and also it saves wall from other failure factors.

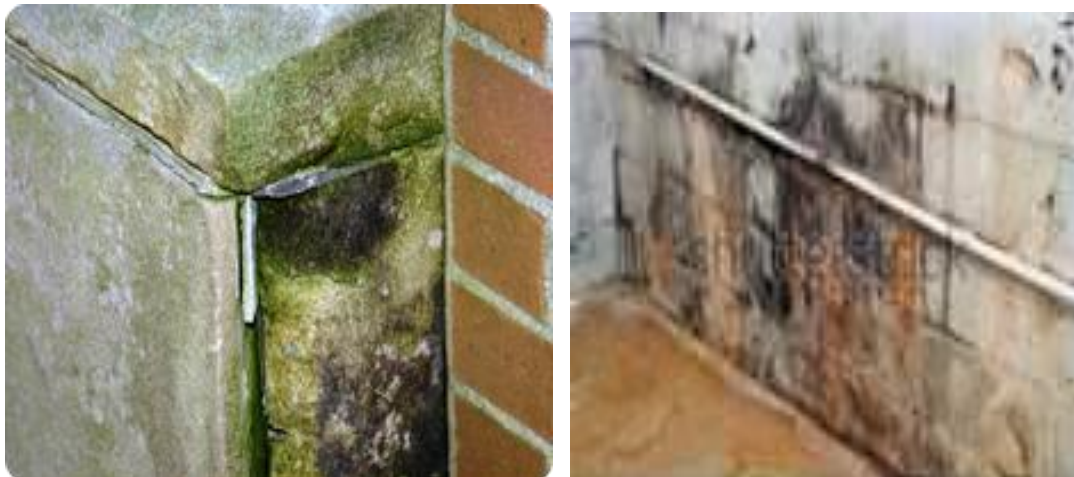
#### **WATER DAMAGE:**

Another problem is water damage, the walls are damaged by the water seepage in the wall and the walls. Short-term exposure to the wall won't harm most building materials, but water quickly damages plaster and dry wall. Common sources of water damage includes leaks in the walls, chimneys, windows, skylight, plumbing, water heaters, and condensation.

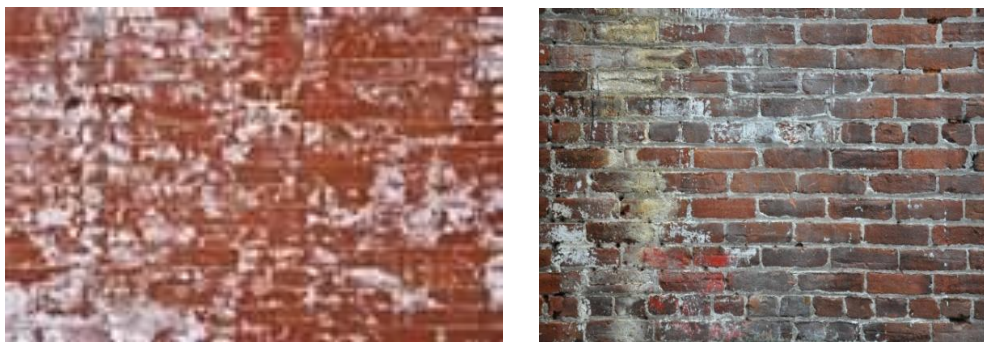
#### **STAINED INTERIOR WALL:**

As we can see in this picture that the wall are stained. This biggest problem is with is sun fades. The picture shows that how the bricks are stained by the Heat and the Water. There might be some other problem but this problem is very severe as the elevation also looks bad.

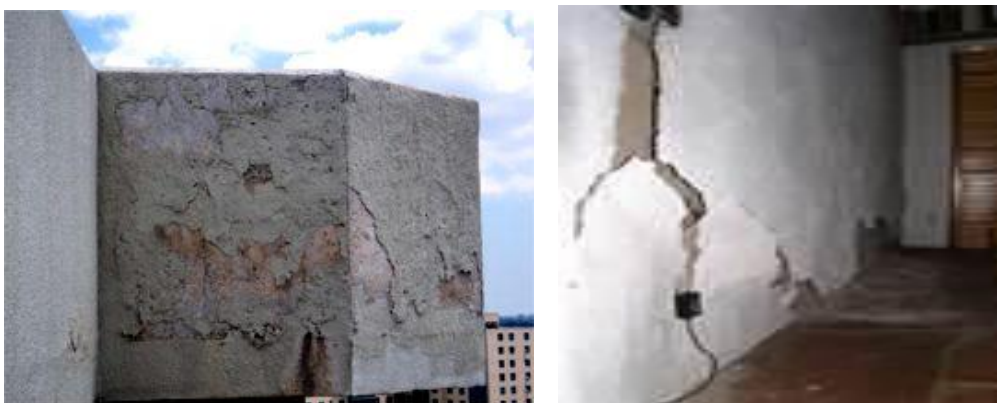
#### **LOOSE PLASTER:**

Generally falling of plaster takes place due to improper plaster work, due to improper mixing of mortar and improper curing and by the water leakage, this type of walls mainly seen at houses, as we can see in the picture, whole plaster is coming out from the wall.

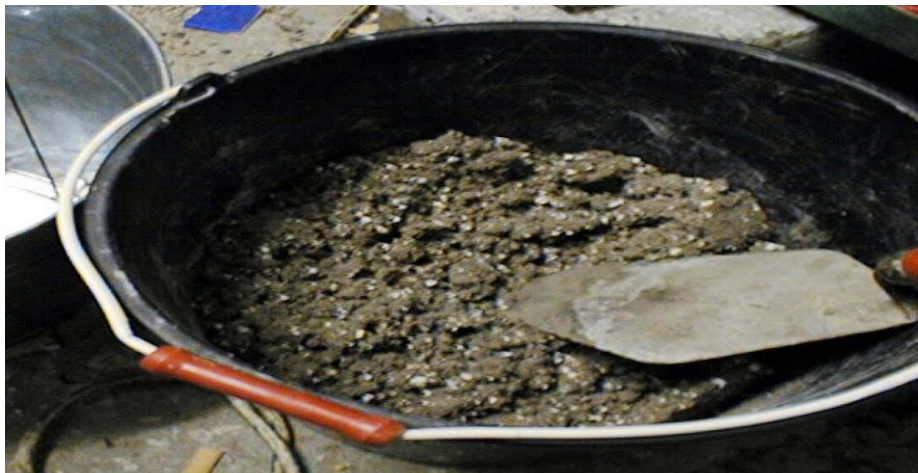
#### **PERILITE CEMENT:**

Perlite is not a trade name but a generic term for naturally occurring siliceous volcanic rock. When Perlite heated to a suitable point in its softening range, it expands 4 to 20 times its original. This expansion is due to the presence of 2-6 % of combined water in the core Perlite rock. When quickly heated to above 8700 C the crude rock pops in manner similar to popcorn as the combined water vapor and creates countless tiny bubbles in the glass – sealed bubbles which account for the excellent insulating properties and light weight concrete It is classified as chemically inert and has a pH of approximately 7.

Perlite is a siliceous volcanic rock. It has been in the form of cement. it is the best insulating material, fire resistant, light weight concrete. it can be used in place of ordinary Portland cement.

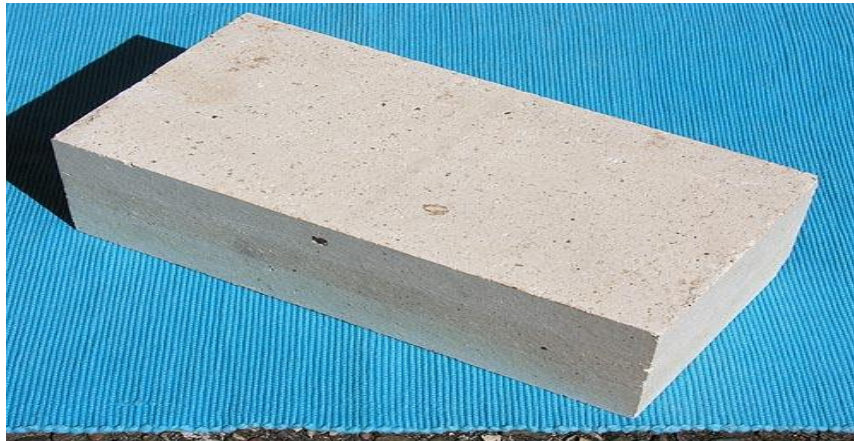
#### THERMAL INSULATION BRICKS

Nowadays they are called heavy and dense Firebricks but old masters still call them fire clay bricks just because they are made of simple fireclay (which actually is the most ordinary mud.) Fire Clay can be easily located out in the nature but it must containing the right refractory properties, suitable content ratio of silica and alumina. Some shops call these bricks fireplace bricks. They are used for instance for building cooking chamber in wood fired ovens, for creating fireplaces, all sorts of fire boxes and wood heaters' lining, linings in a small or the hugest industrial furnaces, you name it. Fire clay bricks are very heavy/dense having low porosity and even on various re-heating, they will last for very/very long time.

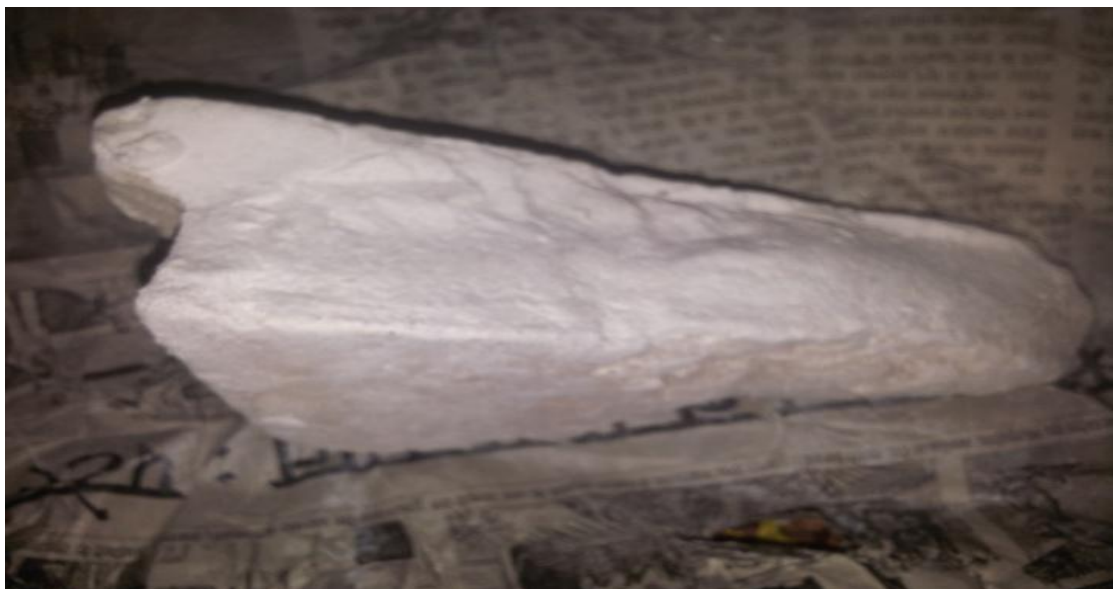
#### INSULITE CEILING SHEETS:

These sheets are made up of different minerals such as Bauxite Crystals, Broken crystals of glass, polystyrene...etc.

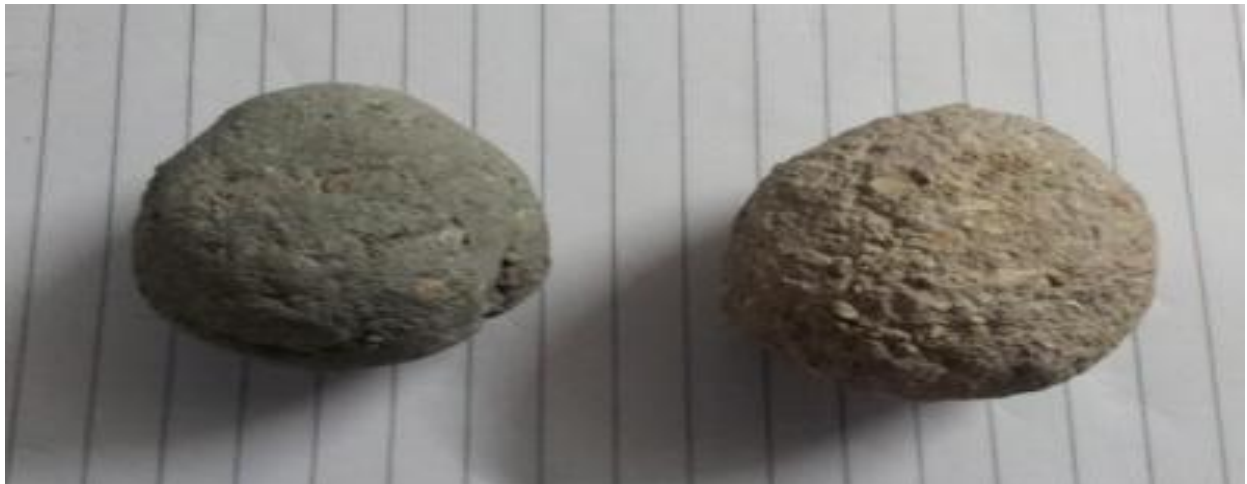
Cement ball before heating & after heating in oven

This Balls are made from the Castable cement. This Balls are self-tested by our group members. In this Process first of all we have made these balls and then kept these Balls in the Oven At 1200 degree Celsius for 24 Hours to check whether the Castable cement can resist the heat or not. Then we have taken out the sample after almost a Day and the results which you can see in this Picture. The balls had changed its color to red but it had resisted the 1200 degrees Celsius. So this Castable cement can be used in Industries, Bakery where the temperature is more in oven and kilns.

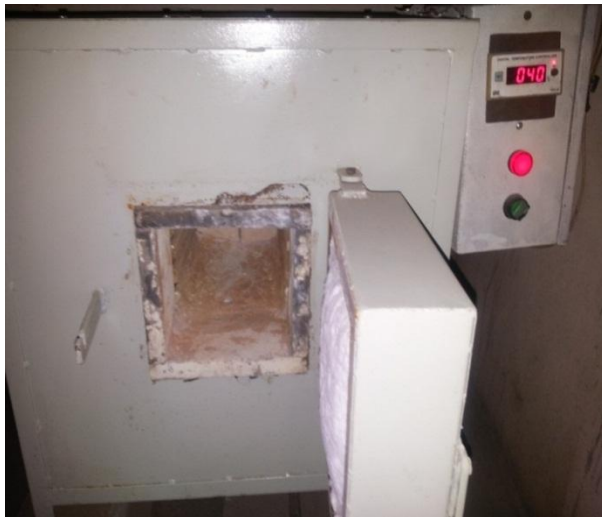
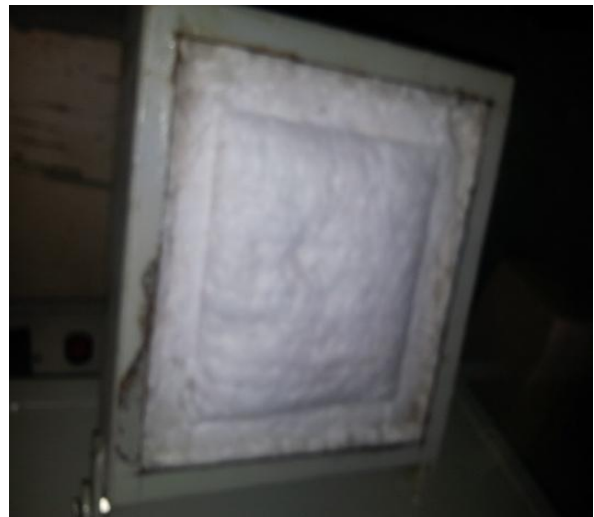
Ceramic fiber wool placed on door of Oven

This is a picture of Oven in which bricks are to be tested for the client's satisfaction. The blanket or cotton sheet is placed on the interior of the oven door. The purpose of this Blanket is to keep and maintain the temperature in the oven. The balls are also tested in this oven for 24 hours at 1200 degree Celsius.

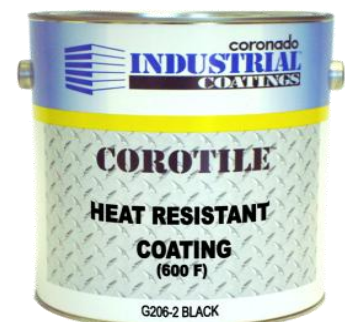
Heat Resistant silicon Paint  
- up to 1200 degrees F, 650  
degrees C.
