Debonding issues of FRP composites with concrete surfaceWaqas Adil¹, Fayyaz-Ur-Rahman², Muhammad Emran³¹Graduate Student, Civil Engineering Department, University of Engineering & Technology, Peshawar, Pakistan.²Lecturer, Civil Engineering Department, University of Engineering & Technology, Peshawar, Pakistan.³Undergraduate student, Civil Engineering Department, University of Engineering & Technology, Peshawar, Pakistan

Keywords: FRP composites; debonding; RC Frame; brittle failure.

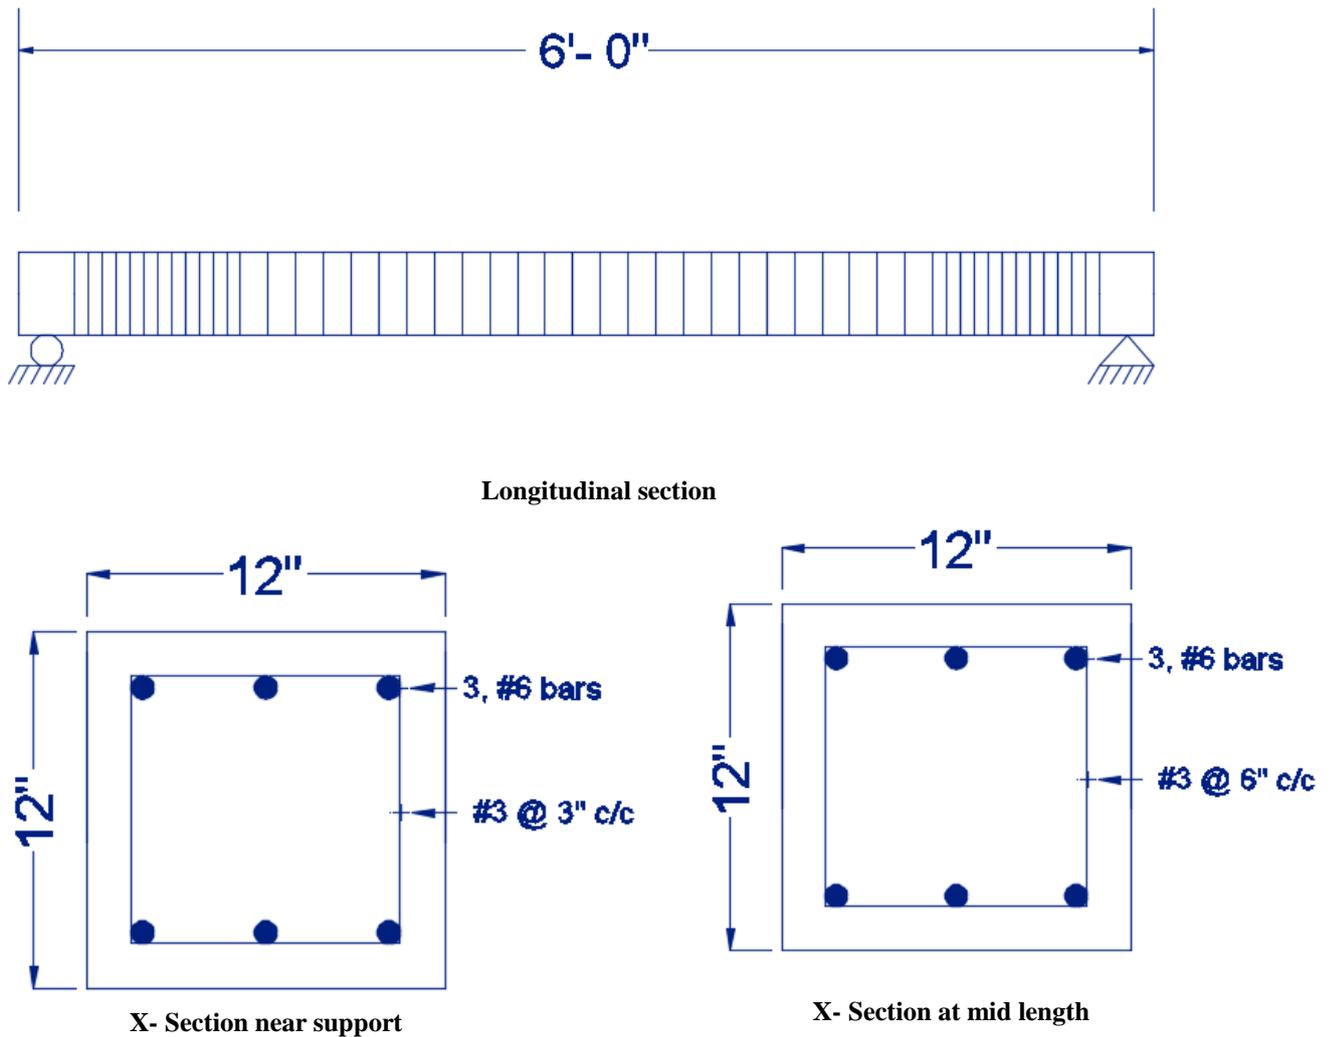
Figure 1. Full scaled reinforce concrete beam and reinforcement details

In this research, reinforced concrete members were studied. Three specimens of beams were casted and tested. The details about beam is given in figure 1.

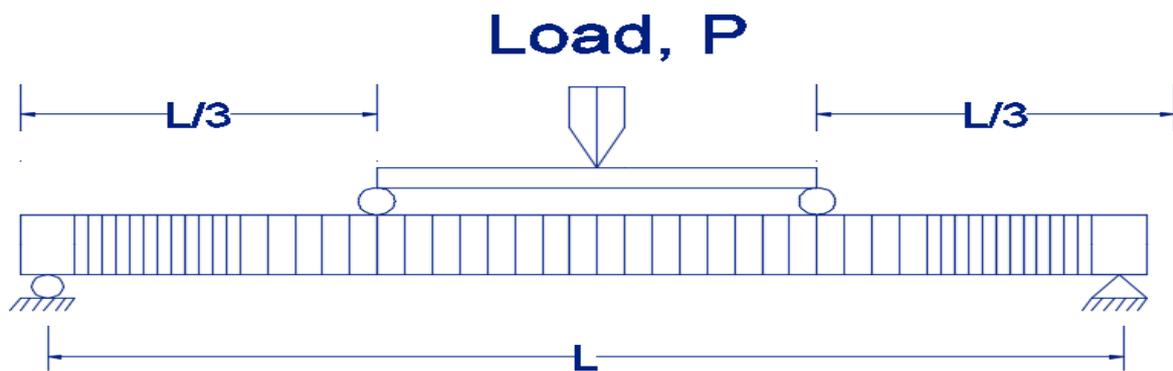
Figure 2. Experimental Setup

The main response quantity to be assessed was flexure strength of specimens. Location of the loading and its rate of application would be such that to give fully flexure response and to avoid any dynamic effect. Third-point loading was applied on the specimens. The experimental setup has been shown in figure 2.

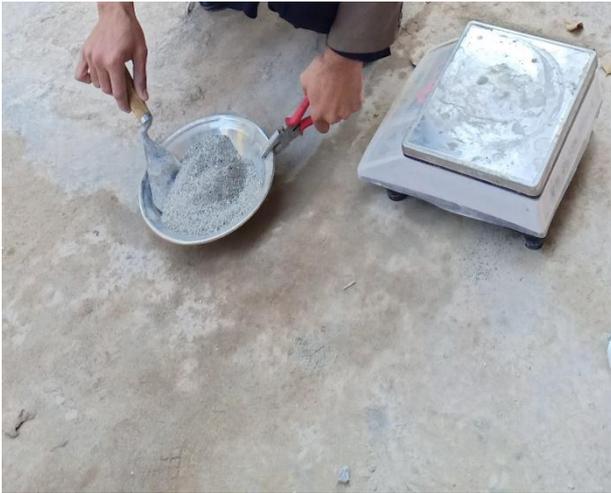
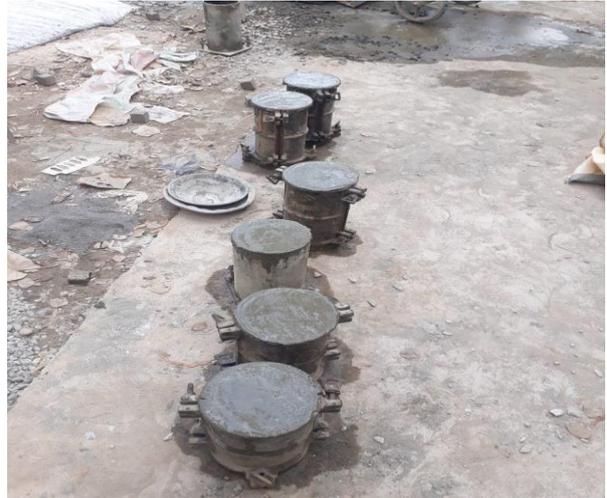
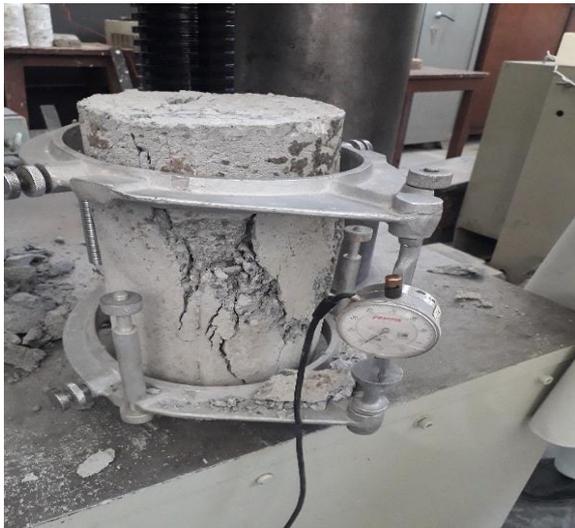
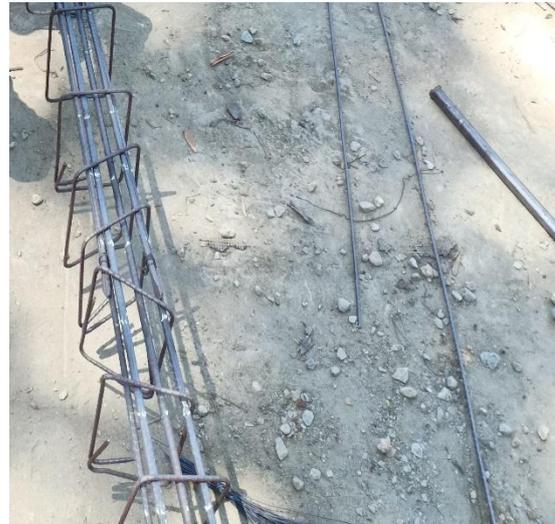
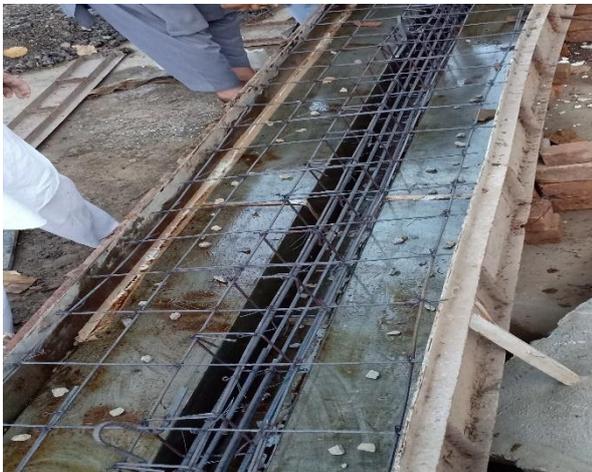
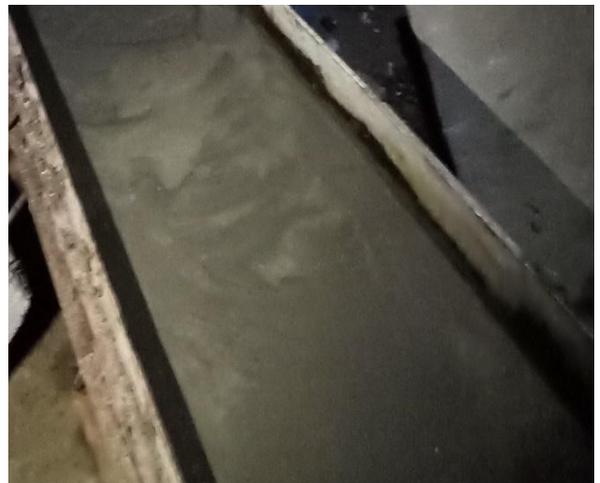
Figure 3. (a) Concrete cylinders casted; (b) Concrete cylinders casted; (c) Concrete cylinder tested by UTM; (d) reinforcement of beam; (d) reinforcement placed in formwork; (f) concreting of beam

Mix design analysis were performed for 28- days compressive strength of 3000 psi concrete. The ratio after mix design analysis was done for concrete found out to be 1:2:2.5 and water to cement ratio was 0.55. Concrete was then prepared with given ratio for verification. Standard sized concrete cylinders were filled with concrete and cured for 28-days. After 28-days, the concrete cylinders were tested with Universal Testing Machine as shown in figure 3. The stress strain curve of the concrete cylinders is shown in figure 3. The average 28-days compressive strength was found out to be 3209 psi. Once concrete strength verified, form work was erected for construction of specimens were done. Specimens were constructed with normal weight concrete. Steel reinforcement of Grade-60 as per ASTM-615 was used in construction. Reinforcement details were such that in beams, 3 #8 bars were used on both side, top and bottom while #3 bar is used as shear reinforcement having 3-inch center to center spacing. Reinforcement details are shown in figure 1. After concreting, specimens were then left for 28 days to fully cured. After fully cured, the formwork was removed and frame were then while wash. At the age of 35-days from concreting in all specimens will be available for testing to get required data. Force controlled loading will be applied to beam. Third point loading will be applied. The experimental setup is shown in figure 4. Once the specimens will be tested then strengthening of beams will be done in as per the standard procedure recommended by ACI 440.2R-08 followed by retesting of retrofitted specimens.

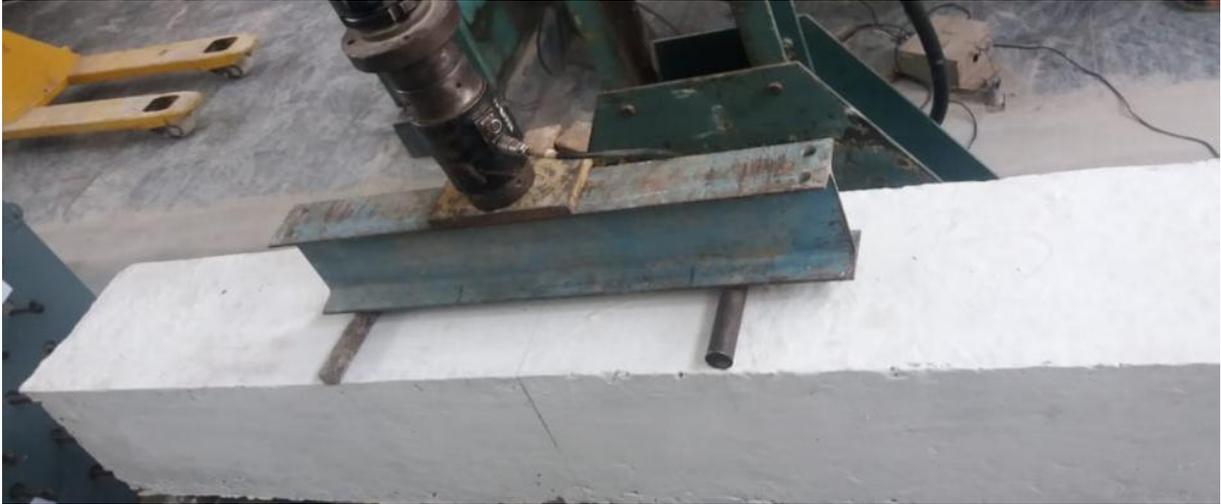
Figure 4. Test Setup for testing controlled specimen

The already constructed specimens were tested. The beams were tested using third point loading as mentioned earlier. All the beams were loaded to full loading and when the drop-in loading occur the test was stopped. The force displacement curve of three tested specimens are plotted as shown in figure 5. The following observations have been observed during test.

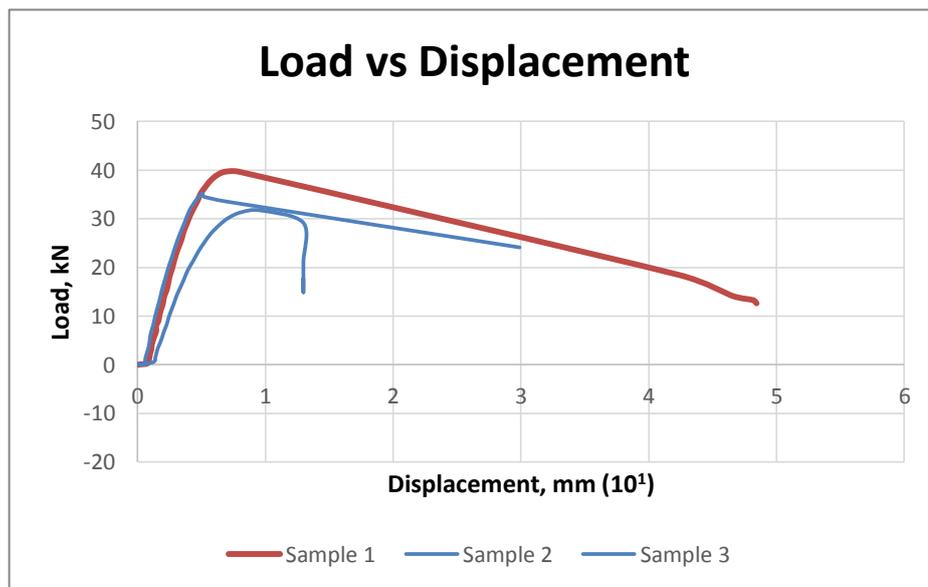
- (1) Initially the specimens show elastic behavior as shown in load displacement curve.
- (2) When load was increased gradually the cracks become appeared in the specimen at mid span of beam, as flexural stress concentration region.
- (3) As the load increased, the already cracks become wider.
- (4) Finally, the test was stopped when concrete on compression side crushed.

Figure 5. Load - Displacement curve for concrete beams
