**EFFECT OF RC CONFINING ELEMENTS ON STIFFNESS OF ADOBE  
MASONRY STRUCTURE**Faisal Zaman Khan<sup>1</sup>,<sup>1</sup> Department of Civil Engineering, University of Engineering and Technology, Peshawar, Pakistan

**Keywords-** Stiffness, Shake table, Seismic capacity, Adobe Masonry, Strength. RC confinements.

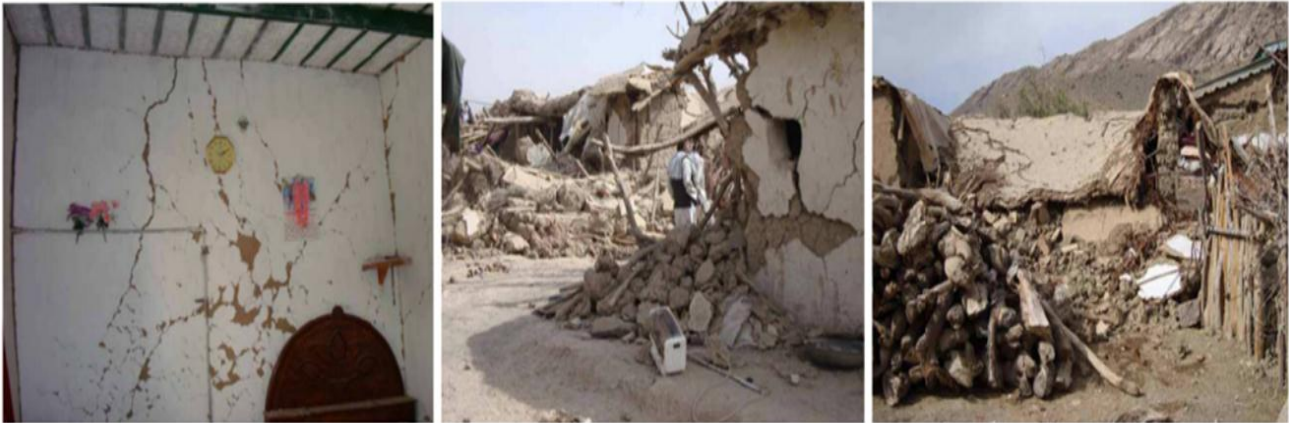
Figure 1.1. Observed damage mechanisms during 2008 Baluchistan Earthquake: In plane shear cracks in wall (Left), in plane cracks and corner failure (Middle), collapse (Right). (N. Ahmad,2011)

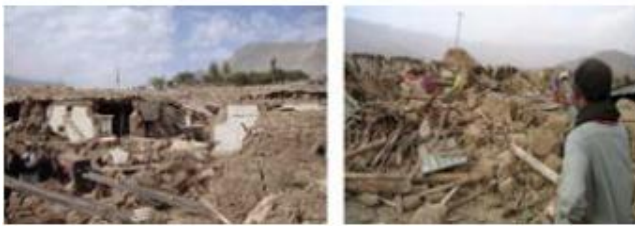
Figure 1.2. Total collapse of adobe houses during the Ziarat Earthquake in 2008 [9]

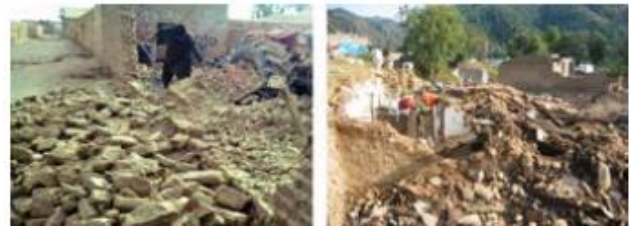
Figure 1.3. Typical damage caused by the Dalbandin Earthquake in 2011 [9]
