Forced Vibration Test on Damaged Reinforced Concrete StructureAttaur Rahman¹, Syed Muhmmad Ali¹¹ Department of Civil Engineering, University of Engineering and Technology Peshawar, Pakistan

Abstract — This paper presents research carried out on damaged reinforced concrete structure using forced vibration technique. Half scaled model of reinforced concrete special moment resisting frame (SMRF) was investigated, which was designed as per Building Code of Pakistan for seismic zone 4. This structure has been tested already dynamically that caused minor damage in the structure columns. The present study now focusses on measuring the dynamic characteristics of damaged reinforced concrete structure in order to understand how the pre-existing cracks and damage in the structure affects the elastic dynamic properties (frequency and elastic damping).

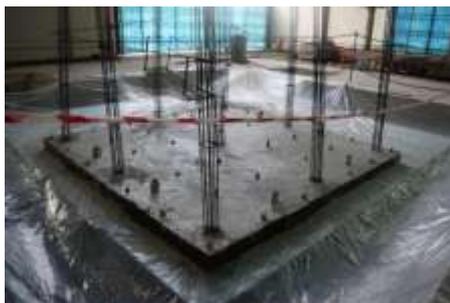
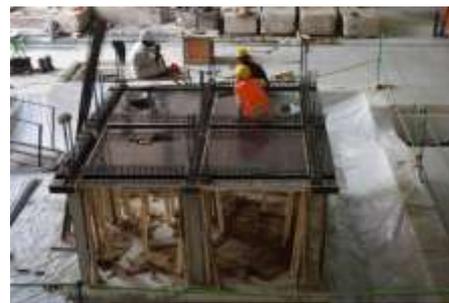
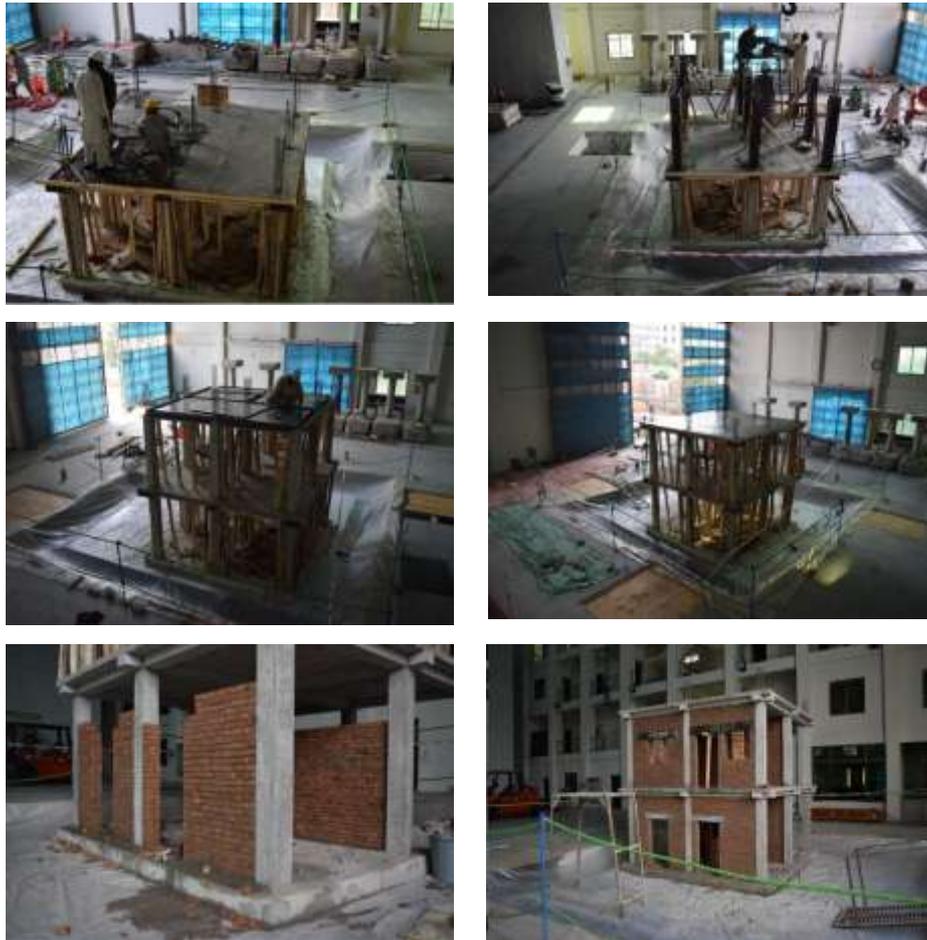
Figure 1: Scheme of construction of test mode

RC frames structures are normally infilled with brick masonry to resist the surrounding moisture, temperature, fire and noise. In these structures the infilled walls are intended as nonstructural elements and usually neglected in structural design and analysis because of a large number of variables such as relative infill to frame stiffness, strength and geometry of infills, position of openings etc. However, under lateral loading the infilled walls can change the failure pattern and load resisting mechanism of RC frames. In failure pattern and load resisting mechanism of URM infilled wall openings (door and window) play a very important role, therefore a half-scaled RC model was constructed on shake table, in which infilled walls with different combination of window and door openings. The scheme of construction of the model is shown in Figure 1.

After the construction of the model, the model was left for curing process to gain strength. Additionally, it was white washed in order to capture good picture of damages, which may occur during the test.

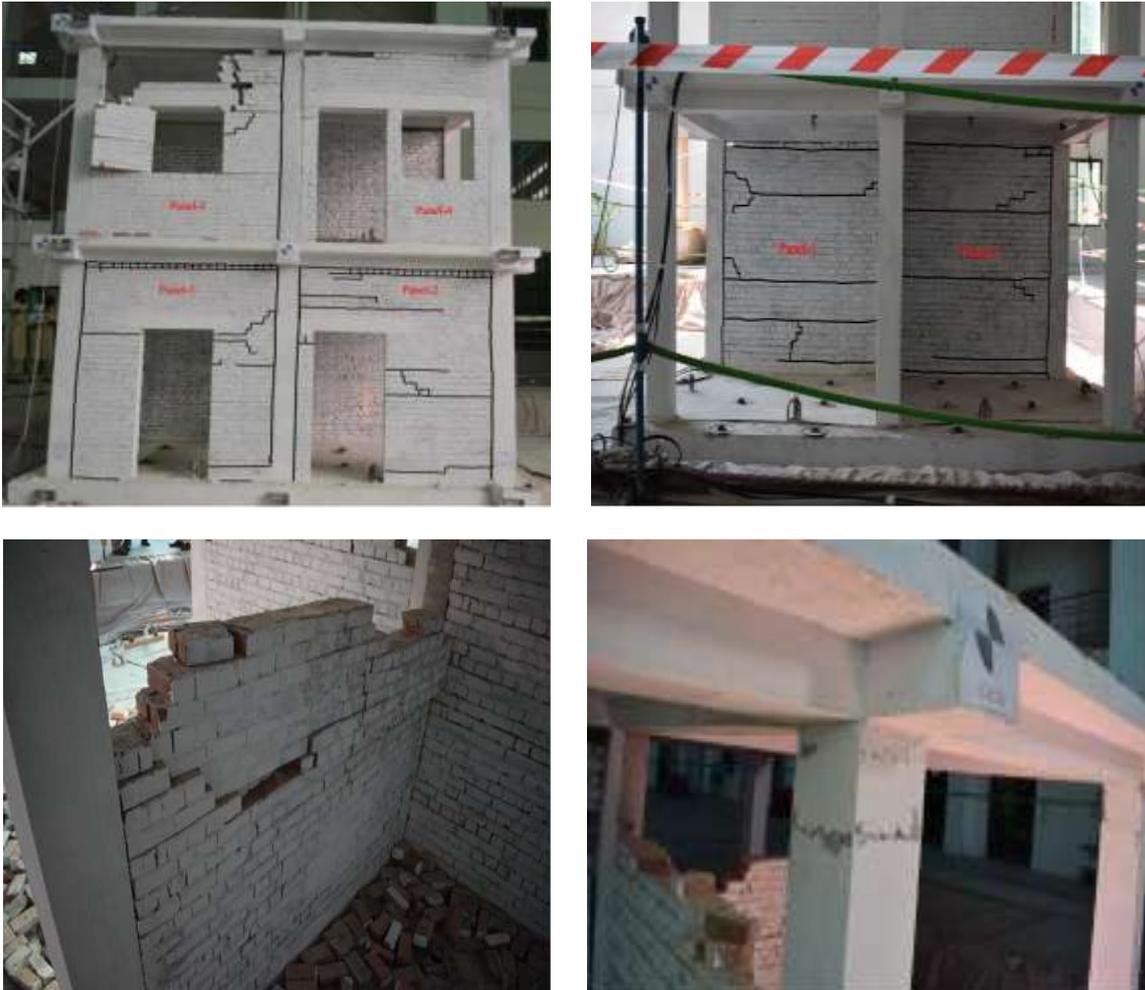
Figure.2: Damage photos of test model

The model was subjected to sinusoidal seismic excitation of varying frequencies and displacements to push the structure from elastic state on inelastic state in a progressive manner. In order to capture response of the model during the test, several accelerometers and displacement transducers were installed on the model at different locations. The damage observations revealed that RC frame members were slightly damaged however, the infill walls were severely damaged as depicted in Figure 2.

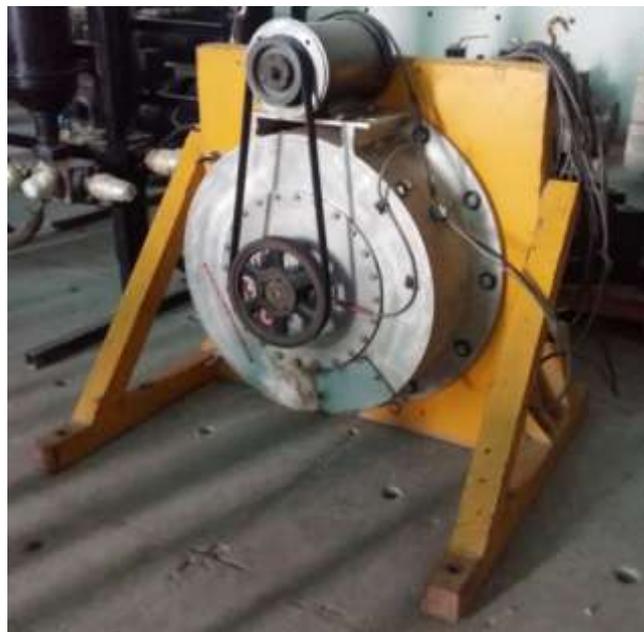
Figure 3: Eccentric Mass Vibrator at Earthquake Engineering Center, UET Peshawar

MK-138 eccentric mass vibrator system owned by the Earthquake Engineering Center, University of Engineering and Technology Peshawar was used as a source of harmonic excitation imposed on the model structure. The particular mass vibrator system is a portable, omnidirectional rotating shaker that can produce a maximum horizontal force of 10 tons and can be operated from 0.1 to 25 Hz. During the forced-vibration tests at Earthquake Engineering Center, the motor drive was operated manually adjusting the operating speed of the shaker to the desired excitation frequency. Pictorial image of the EMV is shown in Figure 3.

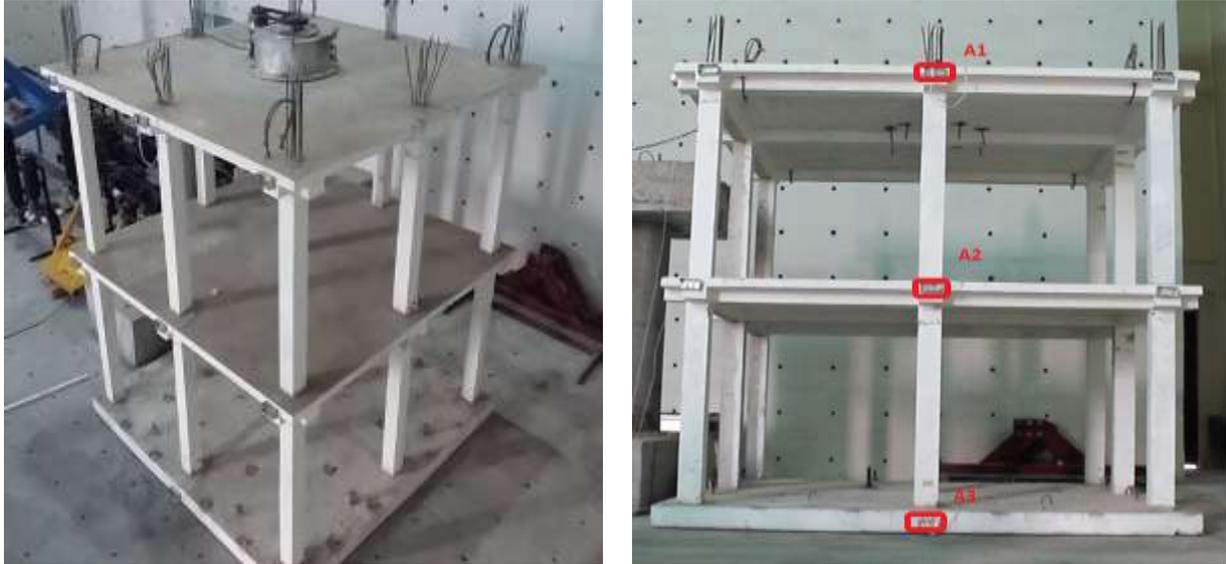
Figure 4: EMV mounted on model (left), instrumentation of model (right)

At the initial stage, EMV was transported to the top slab of the model using 60 tons weighing capacity crane of EEC. The EMV was mounted to slab using nut and bolts, in the already drilled holes as shown in Figure 4 (left). In order to capture the seismic response during the test, the model was instrumented with three accelerometers, one on top floor (A1), one on first floor (A2) and one on base slab (A3), as shown in Figure 4 (right).
