## Repair and Rehabilitation of Concrete structure RCC Column Jacketing: a real time technique

Vatsal Kulkarni<sup>1</sup>, Asst. Prof. Mihir Shah<sup>2</sup> Mr. Jayant Sheth<sup>3</sup>

<sup>1</sup>UG Student, Civil Engineering Department, ITM Universe, Vadodara

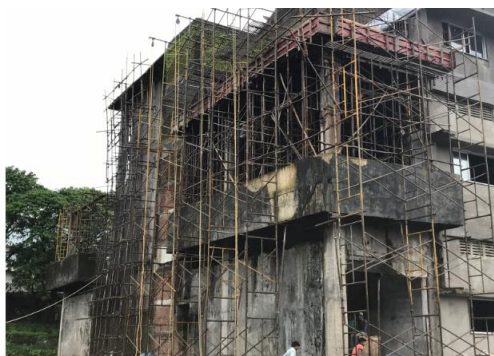
Fig 1 Industrial Building at Panvel, Mumbai

An industrial building which has already completed its life span is being repaired at the site in Panvel, Mumbai. One portion of the building was having four columns with one of its column having lesser dimension compared to the remaining three. Provision of constructing one slab above those columns was to be made, but practically it was not possible to do so because the structure was not having the necessary strength.

Hence the process of jacketing was adopted and one column which was having shorter dimension was redesigned and the slab was constructed as per the need.

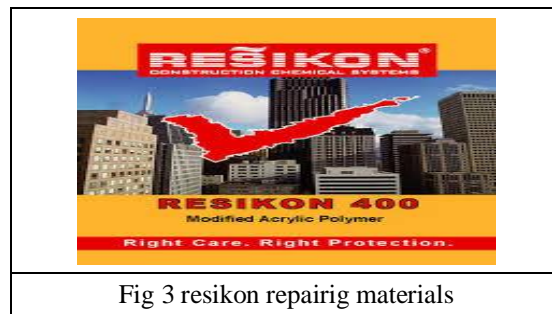
RESIKON 400 is a modified acrylic polymer in emulsion form. It is an excellent material for repair and rehabilitation of different types of structures. It is UV resistant.
