# International Journal of Advance Engineering and Research Development

## RESEARCH PAPER ON GEARBOX FAILURE ANALYSIS

**Abstract-** This paper presents an experimental investigation on gearbox failure of an automobile vehicle. Through the experiment it can identify the main causes of the issue and also the solution of the problem. There are various factors that affects and create a problem of gearbox failure. In this paper, discussion of some problems faced by the company along with their solution has been done.

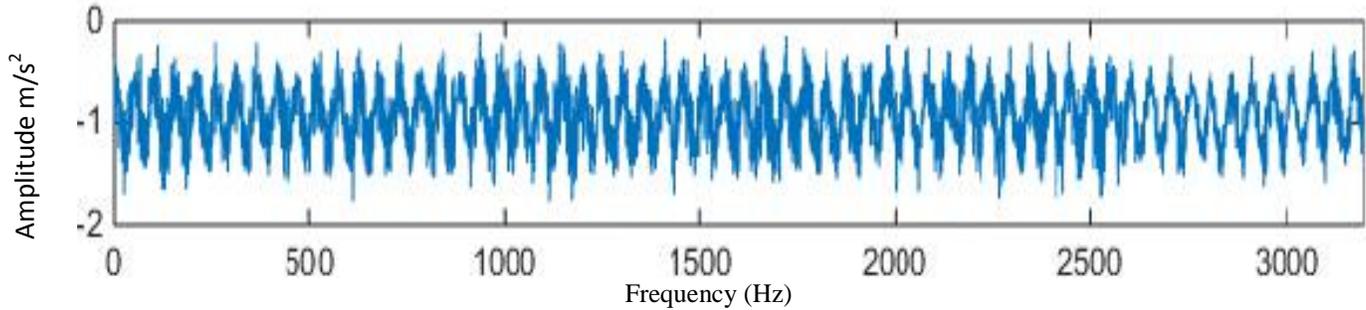
Graph 1. New vehicle Vibration signals acquired for 4th gear 50 km/hr

The Graph 1 shows vibration signals of a new vehicle at 50 km/hr at 4<sup>th</sup> gear with the shaft speed of 11200 RPM.

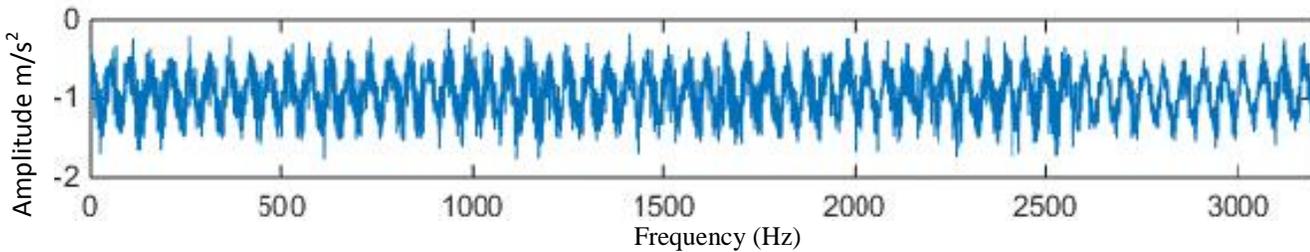
Graph 2. For old vehicle Vibration signals acquired for 4th gear 50 km/hr

Graph 2 shows old vehicle running at speed of 50 km/hr at 4<sup>th</sup> gear with the shaft speed of 11200 RPM.

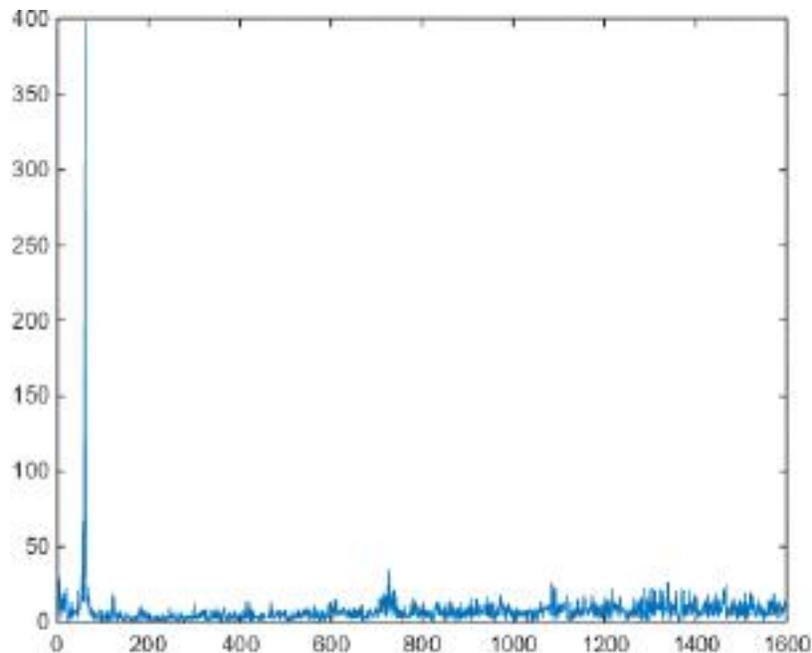
Graph 1. New vehicle frequency domain analysis

By Fast Frequency Transform we get graph of a new vehicle running at speed of 50 km/hr at 4<sup>th</sup> gear. Here we cannot see any abnormal rise in frequency graph. Thus it can be say that the new vehicle does not have any problem in gearbox, but this Graph has to be compare with the old vehicle graph to get better idea.

By comparing Graph 3 and Graph 4 we can see that there is abnormal rise in a Frequency at 750 Hz. For knowing the frequency of failure calculation has be done. As per 5 why analysis the bearing and tooth failure resemble major defect the calculation will be done for them first. If no frequency match then other failure frequency will be calculated [2]. For Ball bearing Failure frequency

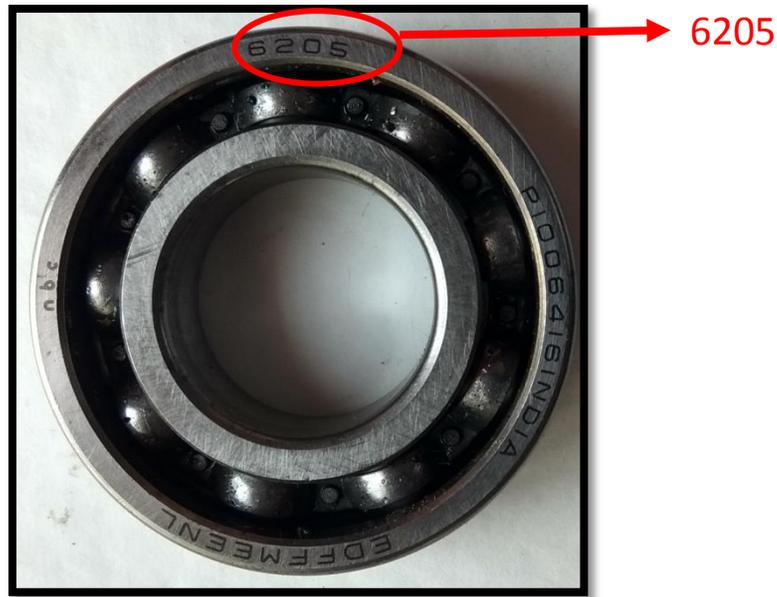
Figure 5. NBC ball bearing

As we can see that  $w_{bp}$  is 750 Hz, which shows that the outer race off ball bearing has some problem.

The ball bearing is manufactured by National Bearing Company (NBC).

In CMM it is found that the tolerance limits is between the  $+0.003$  to  $-0.022$ , which is not in the limits. Here more clearance is provided.

Bearing OD is higher than the OD of housing, bearing is press fitted here. Bearing clearance will decrease as temperature increases inside gearbox. But already more tolerance is provided which means that at higher the clearance will be more compare to desired value. So the bearing is loosely fitted inside housing, which will rotate at higher RPM, and also failure of other components. The new Tolerance Limit for Housing is  $+0.0030$  to  $-0.0010$ .

- Gearbox failure is due to the ball bearing failure.
- There is a Ball bearing failure due to the more tolerances provide in housing
- New Housing with suitable tolerances has been suggested.
