Repair and Rehabilitation of Structure after Fire Damage: A Case Study of an Industrial Building

Abstract: This paper presents a case study on a rehabilitation of a fire damaged industrial building. Detailed site investigation and NDT test are conducted to decide the repair methodology. The fire incident took place in a mixer unit of a 50 year old manufacturing unit. The fire ignited at ground floor due to short circuit in electric panel. The mixer building is (RCC framed) ground and two upper floor structure. Concrete core samples are taken and tested for residual strength. Rehabilitation plan is designed on the basis of site investigation and results of test conducted.

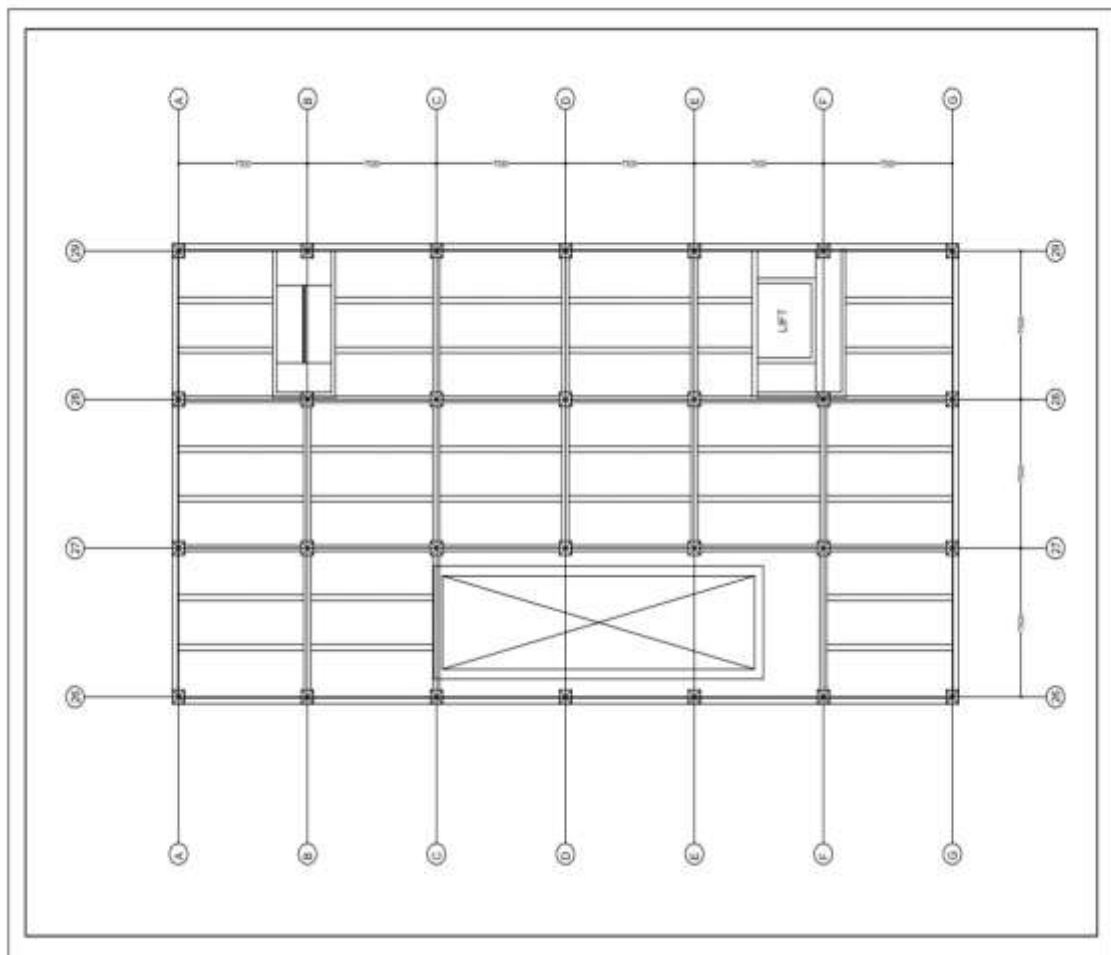
Fig.3 Grid line plan of typical floor

On the first floor reclaimed rubber, machine oil, FRP pallets and drums were kept. Rubber is burnt partially and pallets are partially melted. Remains of MS frame of oil drums neither bent nor melted. RC beam and slab in the grid B26-C27, D28-D29 were affected by fire and heat. Spalling of cover concrete is observed. Reinforcement is exposed in certain members. Inspection of mild steel reinforcement in RC members doesn't show any de bond condition. No powdered steel existence is observed. Freshly broken concrete shows grey colour. Plaster of all members is completely damaged on the first floor. Plaster surface shows crazing and cracking.

The slab needs to be repaired by surface repair method using epoxy-injection or mortar grouting. Beam and slab in grid lines B28- C26-C 28 are retrofitted by anchoring steel members to the damaged surface as below.
