CHANGE ANALYSIS OF BANK LINE MIGRATION, EROSION AND SEDIMENTATION PATTERNS AT LOWER REACHES OF MAHI RIVER, GUJARAT USING REMOTE SENSING AND GIS

Rahul Panchal¹, R.M.Jadav², Indraprakash³, Khalid Mehmud⁴

Abstract — A number of dams have been constructed across the Mahi River in Gujarat state. Lower reaches of Mahi River from Sindhrot dam, near Vadodara to Gulf of khambhat, in 176 km length, has been selected for the change analysis of bank line migration, erosion and sedimentation pattern. Satellite imageries (LISS III) from 1990 to 2016 and google earth images have been used in the analysis in GIS environment. The study indicated that the river reaches from Tithor to Sona Talavadi is currently under active erosion. It has been observed that area of erosion is more than deposition. Probably it is due to checking of the sediments by the dams located in the upstream. Migration of bank lines from 1990 to 2016 is maximum towards southern side in the central portion and in the northern side at the river mouth within the flood plain.

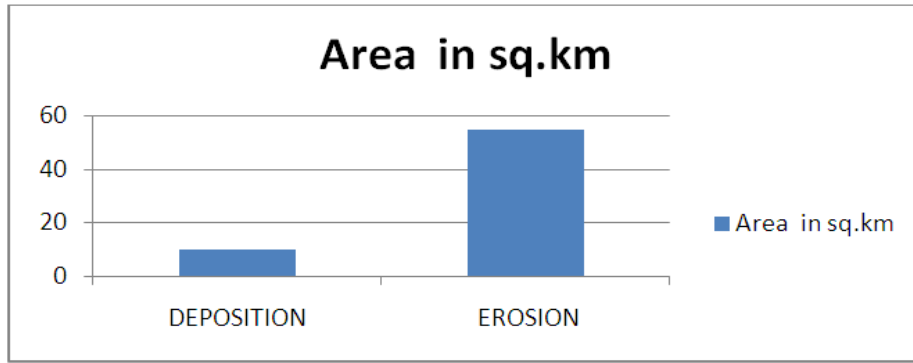
Figure 4-Total erosion/deposition along banks of lower Mahi River from 1990 to 2016.

Figure no:4 shows the total amount of erosion and deposition along the Mahi River banks. ,

The total amount of erosion estimated is in 54.632 km² area and deposition in 10.079 km² area.
