## EXPERIMENTAL INVESTIGATION OF THE FAILURE MECHANISM OF THE ZONED COHESIVE EARTHFILL DAMS

**Abstract** — Earthfill dams are the common manmade hydraulic structures constructed all over the world. Breaching of an earthfill dam can leads to catastrophic damage to downstream communities, substantial loss of life, environmental damages, and momentous property damages. This research paper aims to investigate the breach pattern of the zoned cohesive earthfill dams due to overtopping. Two small-scale laboratory experiments with different mode of initiation of breaching process, flat crest top level and an initial pilot channel erected at middle of crest were conducted. The dimensions of placed model were, 12 inches crest width, 30 inches crest length, 20 inch crest height, and 1:2 upstream and downstream side slopes. The results indicated that headcut erosion has a vital role in the breach development process of cohesive zoned embankments. The breach cross section has almost a trapezoidal shape. The final breach section width reached to the full width of the dam in case of flat top crest level test while it was confined to the middle of the dam in case of test performed with initial pi

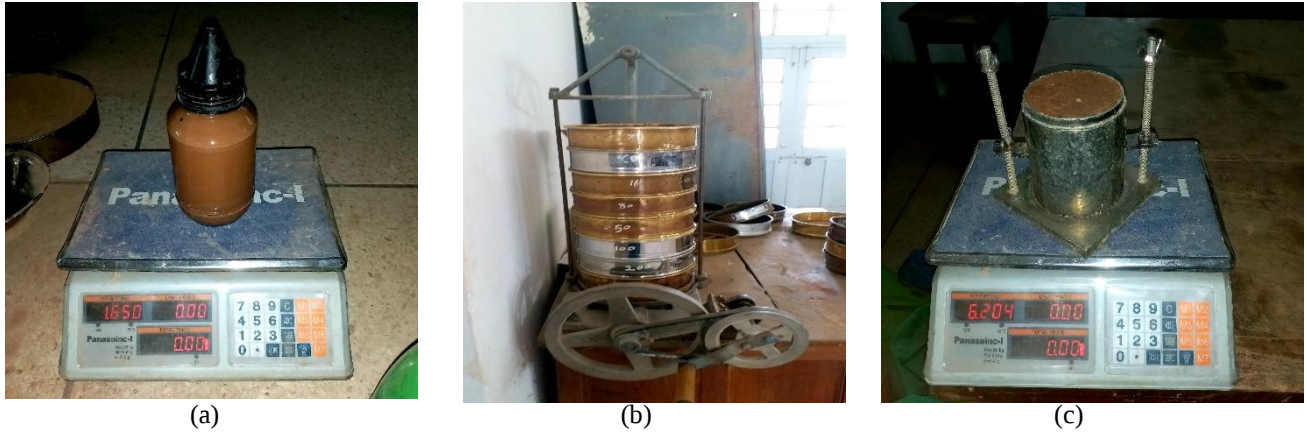
Figure 2.1. Laboratory tests of the selected soil samples (a) specific gravity test, (b) sieve analysis test, (c) standard proctor compaction test

Essential laboratory tests were conducted to acquire necessary soil parameters. The tests carried out are specific gravity, atterberg limits, soil gradation, and proctor compaction test. Figure 2.1 provides the illustration of the various soil test conducted to obtain the different soil parameters. Results of the laboratory tests are given in the Table 2.1. The soil gradation curve is given in the Figure 2.2.

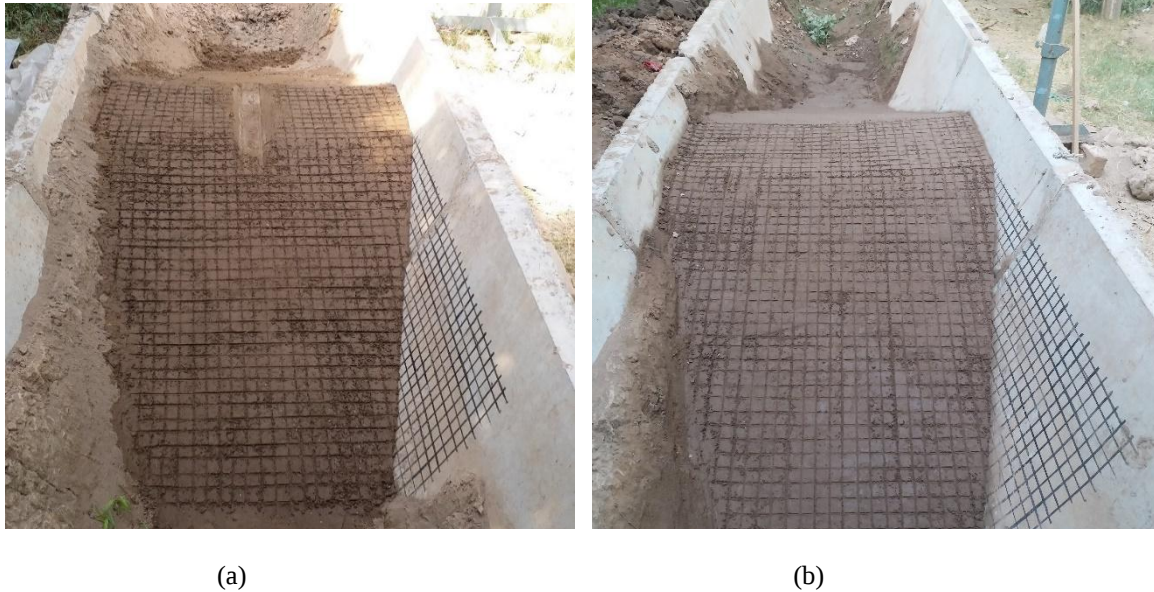
Figure 2.5. Illustration of the dam model placed in the channel (a) initial pilot channel provided at the middle of the crest (b) flat crest top level

The earthfill dam models were constructed in the channel by placing the soil in loose horizontal layers. The model was placed in four layers. A hand compactor was used for compaction of each loose layer. Each layer was compacted almost to half of its initial thickness. After compaction of each layer, soil samples were collected and tested in the soil mechanics laboratory to obtain the achieved dry density and moisture content. Figure 2.5 provides the illustration of the placed model in the channel.

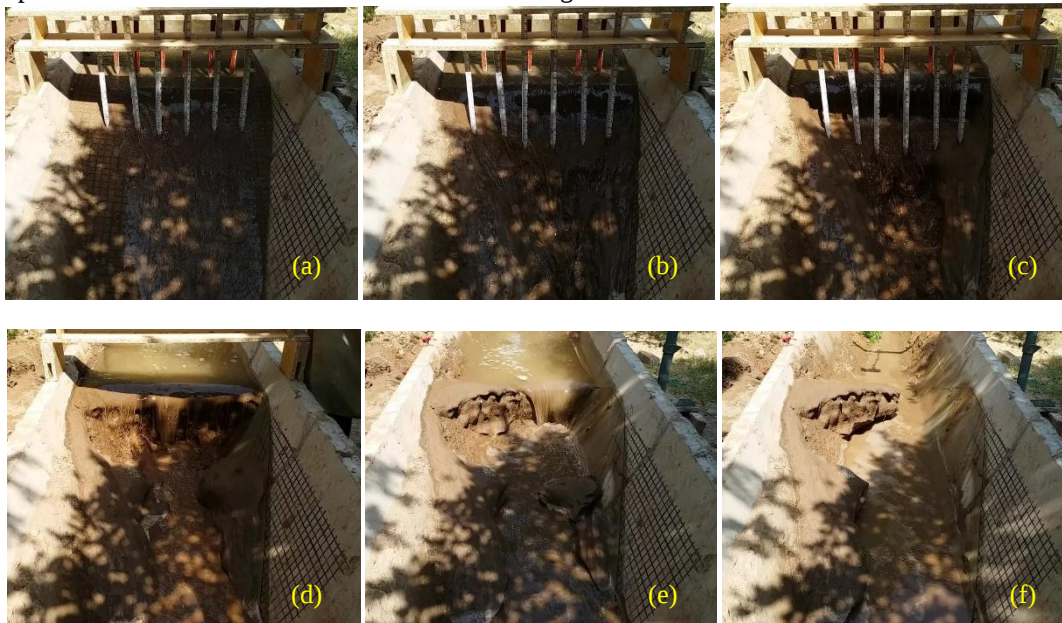
Figure 2.6. Breach development process (test 2): (a) rill and sheet erosion at  $t = 20$  sec (stage-1), (b) formation of headcut at  $t = 85$  sec (stage-2), (c) migration of headcut toward crest of embankment at  $t = 160$  sec (transition from stage -2 to stage -3), (d) erosion of crest and clay core at  $t = 330$  sec (stage-4) (e) headcut at upstream side (lowering of crest level) during stage-4 at  $t = 535$  sec (f) complete failure at  $t = 845$  sec.

Four stages were observed during the breaching process which are surface erosion, headcut formation and migration, lowering of the crest, and lateral erosion as shown in the Figure 2.6. Surface erosion initiates the breaching process with erosion of soil particles from downstream face near toe of the dam. The surface erosion results in formation of a headcut and ceases when it is fully developed. Then headcut erosion dominates the failure process. The headcut progresses toward the upstream of the embankment crest and continues to grow both in horizontal and vertical direction.
